LIMITED STRUCTURAL ASSESSMENT

Glulam Arches at the Malcolm Yonge Center

925 E Jackson St.

April 21, 2023

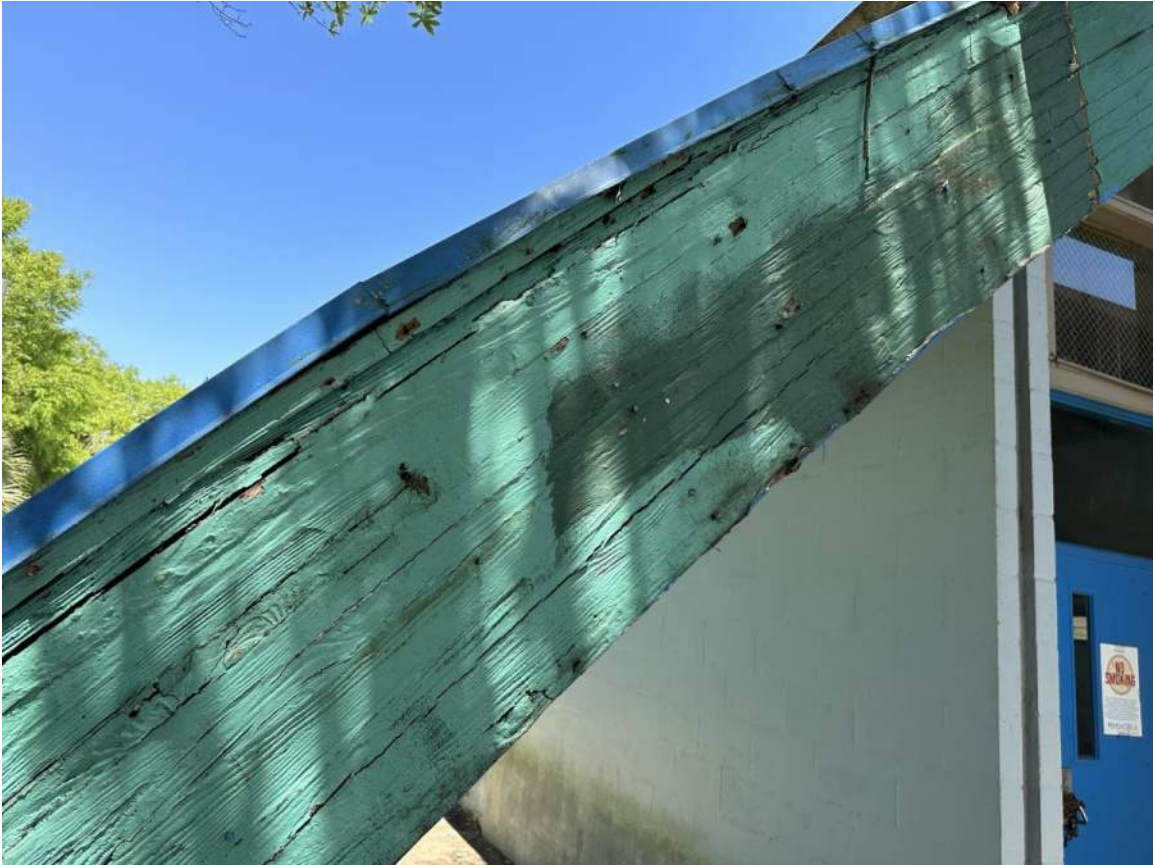
Arch #1 at South Side of Bldg
(Viewing West End of Arch between Concrete Buttress and west wall)
NOTE: Excessive / Severe Decay & Delamination

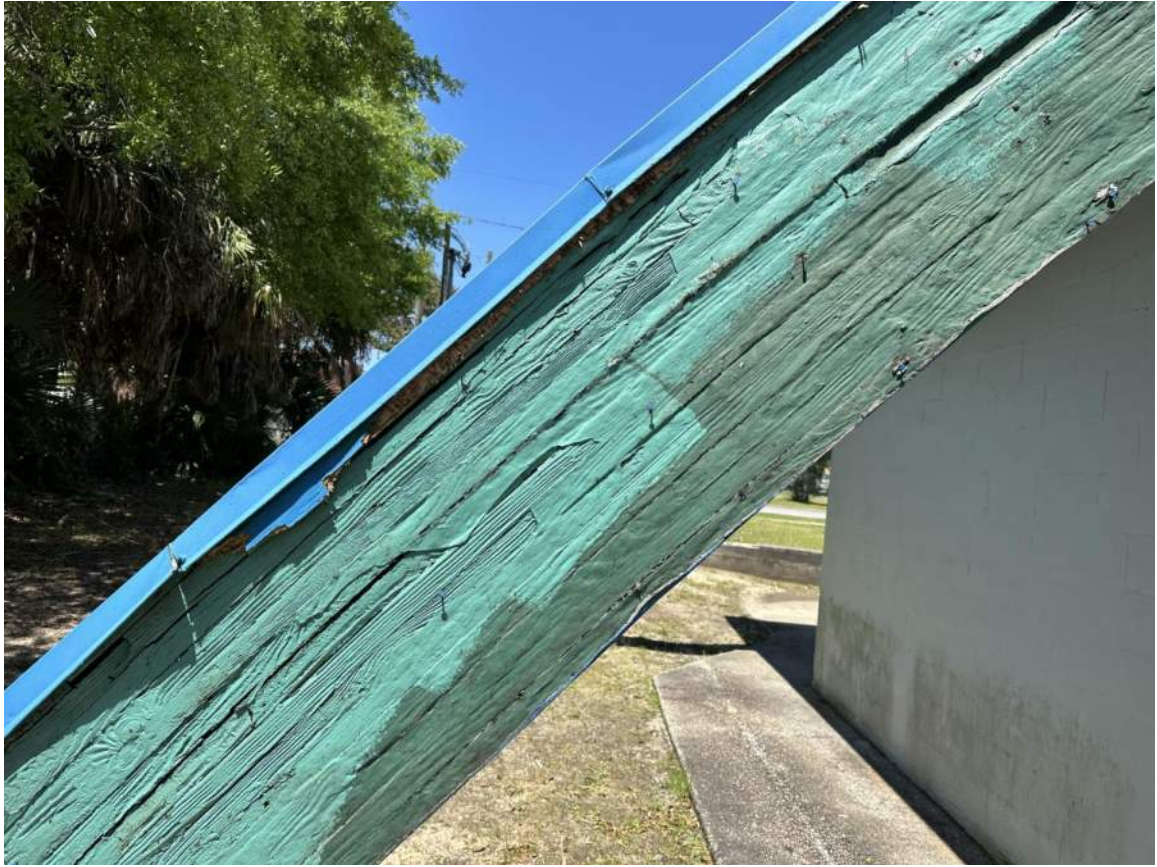
**Arch #6; West End of Arch near NW corner of Bldg
(Viewing West portion of Arch just above Concrete Buttress)**

NOTE: Severe delamination & decay

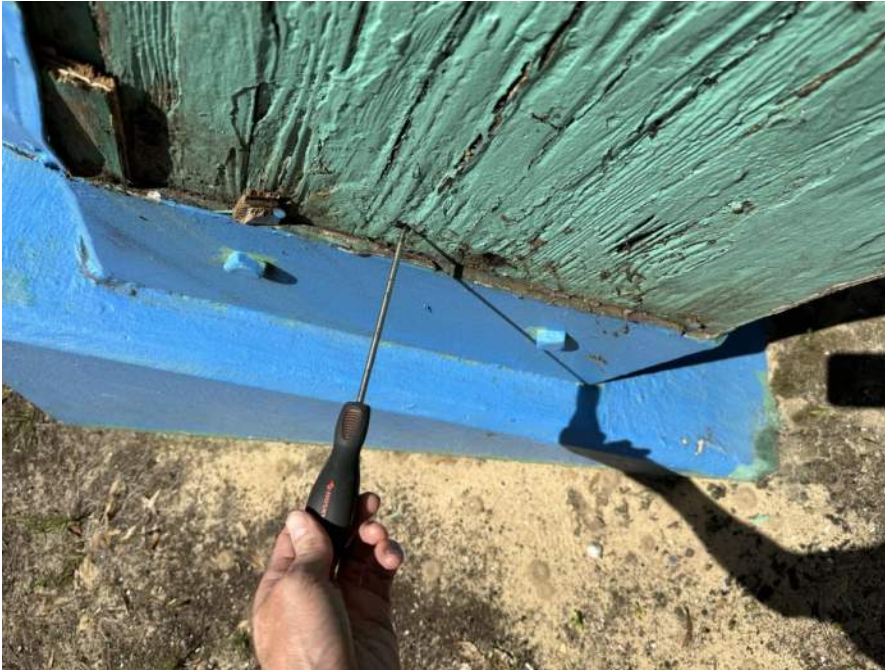
**Arch #6; West End of Arch near NW corner of Bldg
(Viewing West portion of Arch bearing on Concrete Buttress)**

NOTE: Severe delamination & decay with screwdriver easily penetrating member

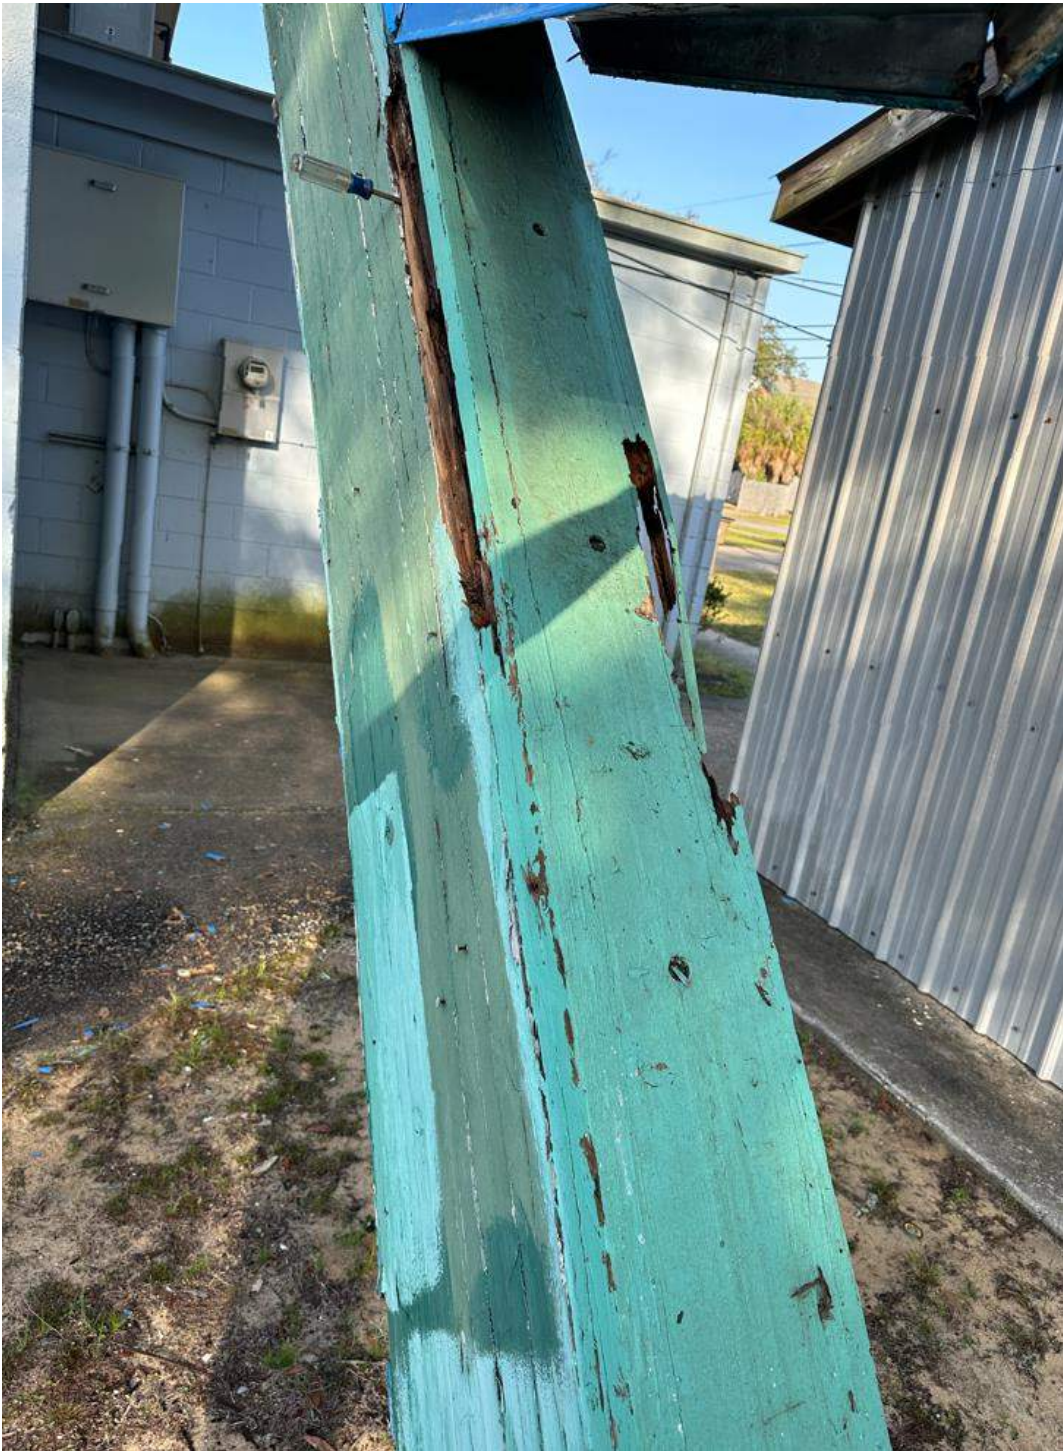
Arch #7; East End of Arch near NE corner of Bldg

NOTE: Severe delamination & decay

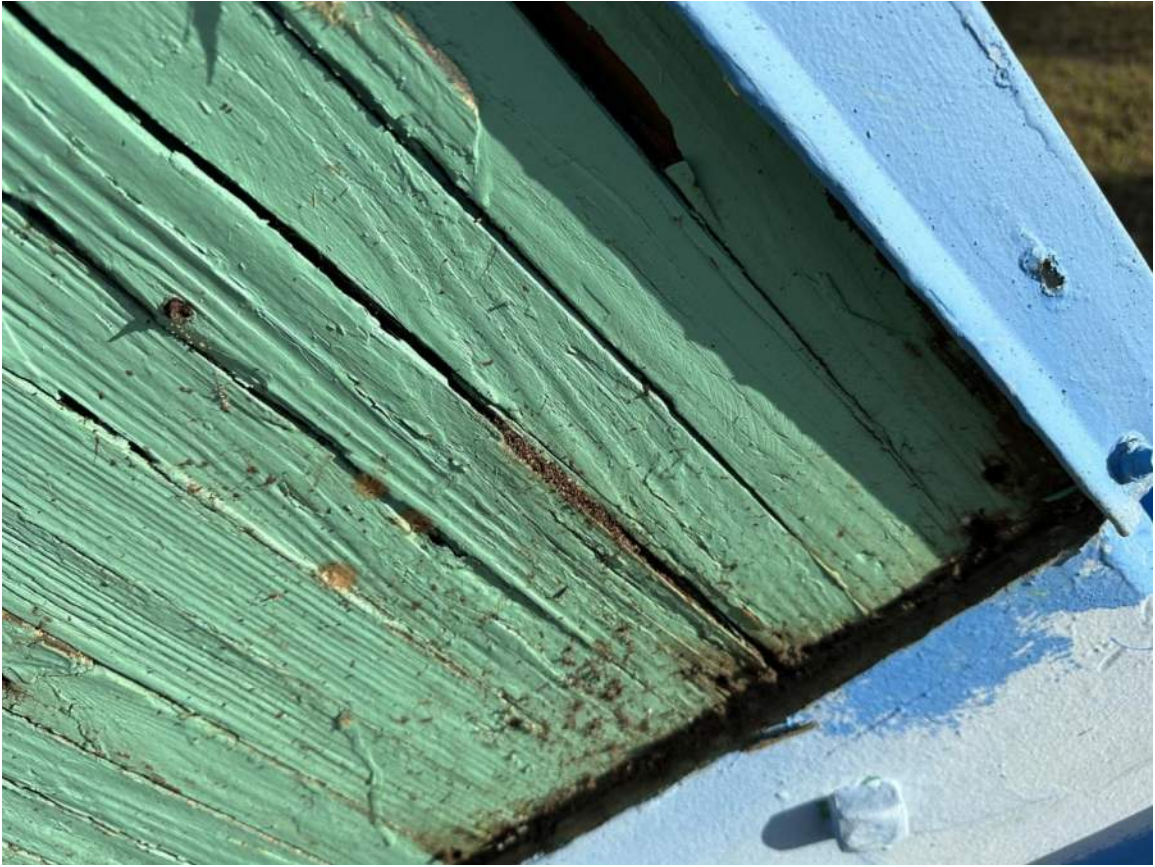
Arch #4 in Photo Foreground; East End of Arch

NOTE: Severe delamination & decay

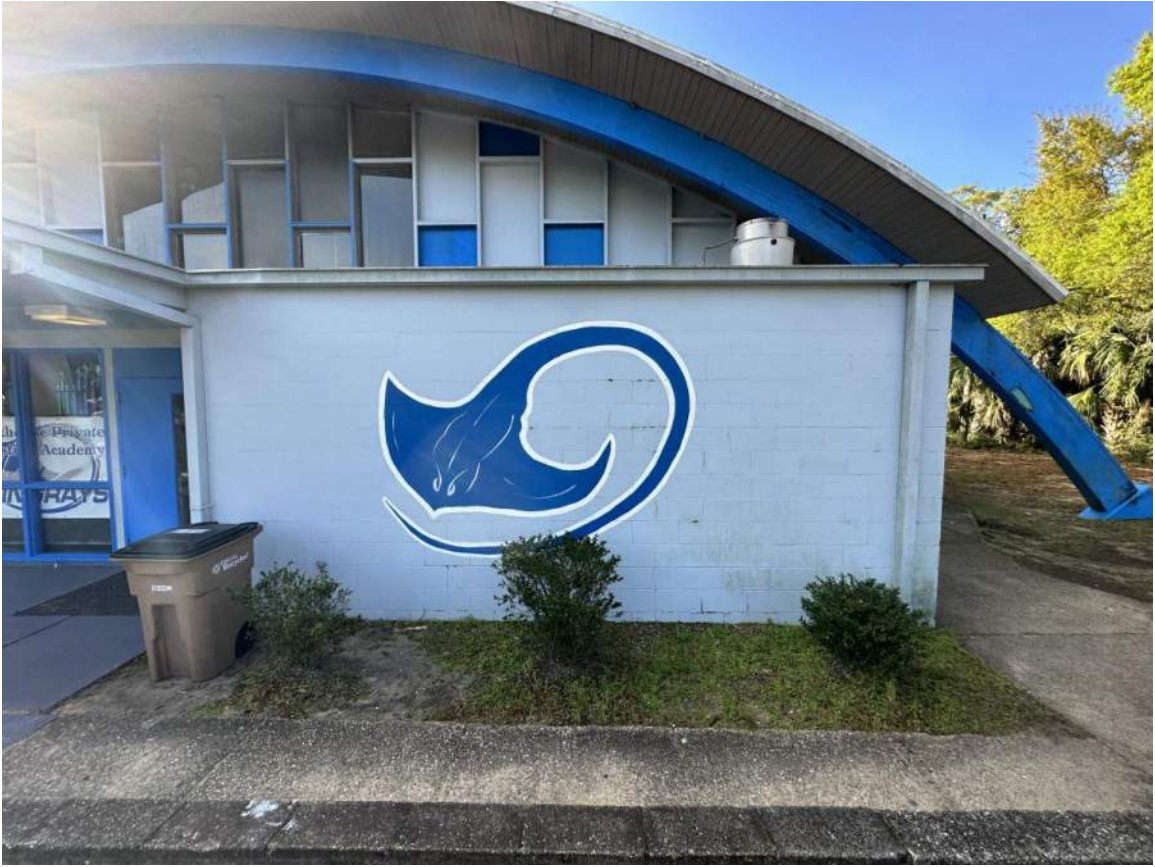
The exterior walls are comprised of concrete block masonry and other glazing systems. We noticed signs of stair stepped cracking along the block walls just west of the north lobby entrance. While the cracking is not severe, it is indicative of differential foundation movement or excessive settlement.

We also noticed stair stepped cracking of the exterior concrete block wall located on the west side of the north lobby entrance.

**Arch #7 & Cracked CMU Wall at North Side of Bldg
(Looking South)**
