## LIMITED STRUCTURAL ASSESSMENT

Glulam Arches at the Malcolm Yonge Center

925 E Jackson St.

April 21, 2023

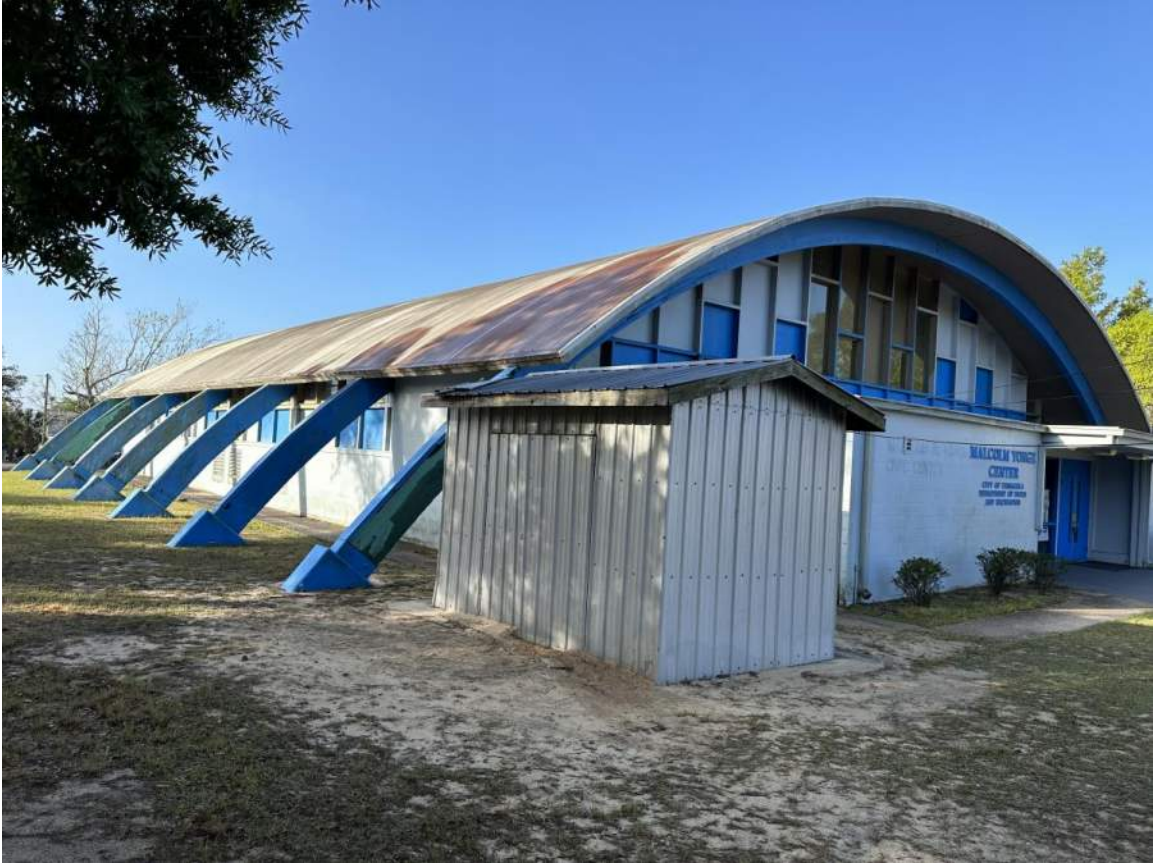
**North Side of Building  
(Looking SW)**

**NOTE: Arch #7 is on north side and #1 is in the rear of the photo**

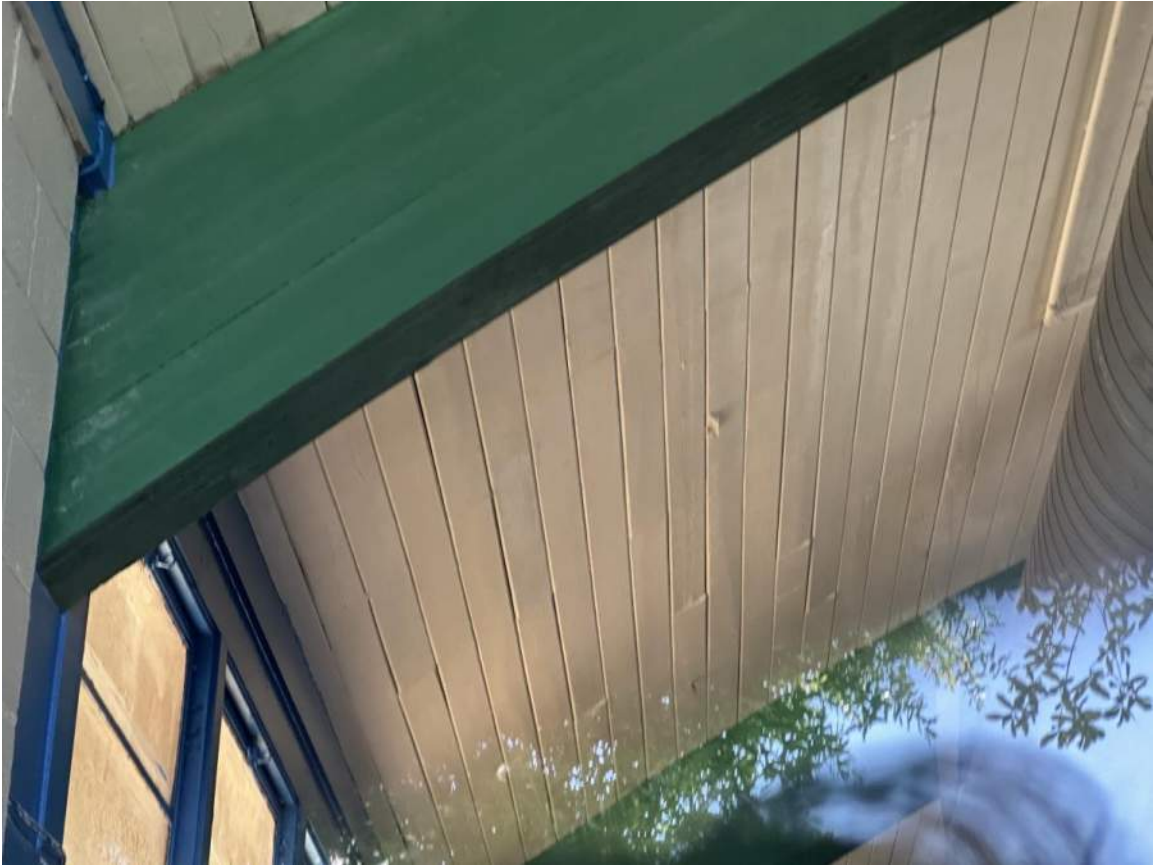
**Inside of Bldg – Arch #3 Passing Through East Wall**

**NOTE: Notice delamination near bottom of Arch**

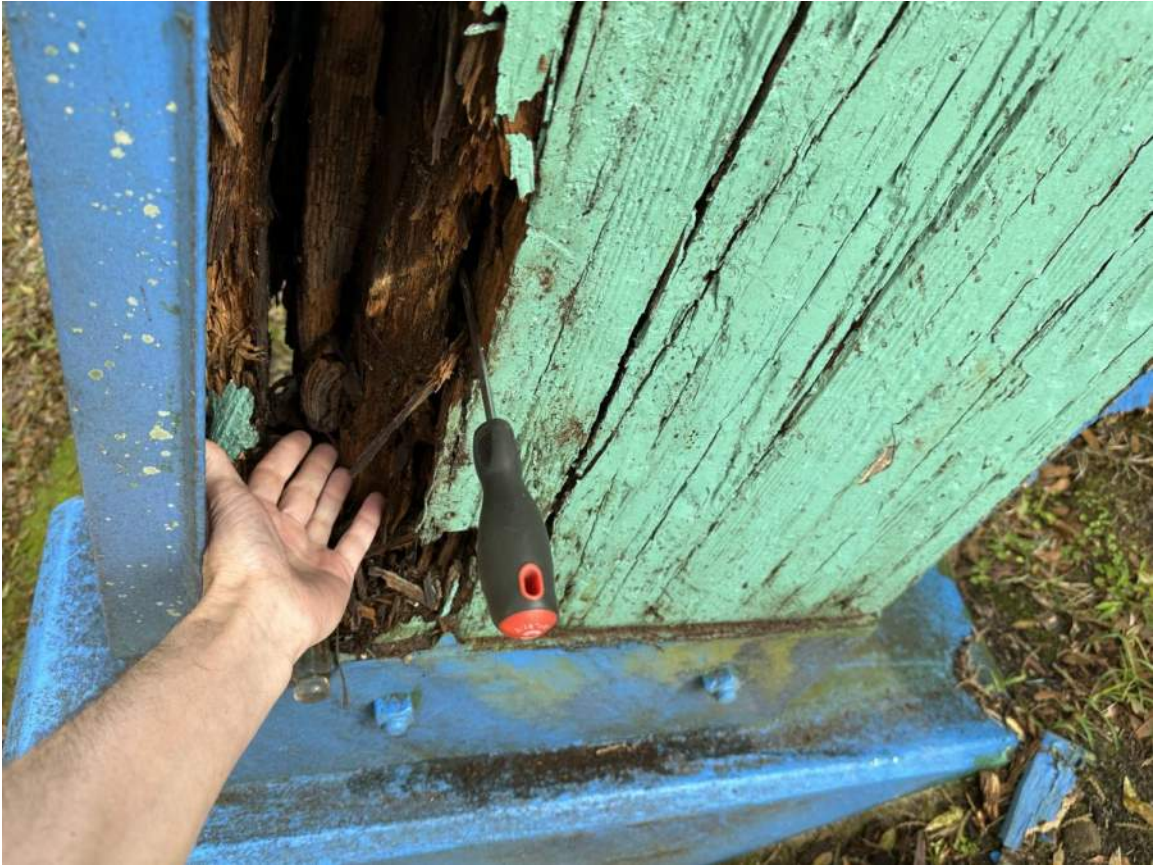
**Arch #1 at South Side of Bldg**  
**(Viewing West End of Arch at Concrete Buttress)**  
**NOTE: Excessive / Severe Decay**

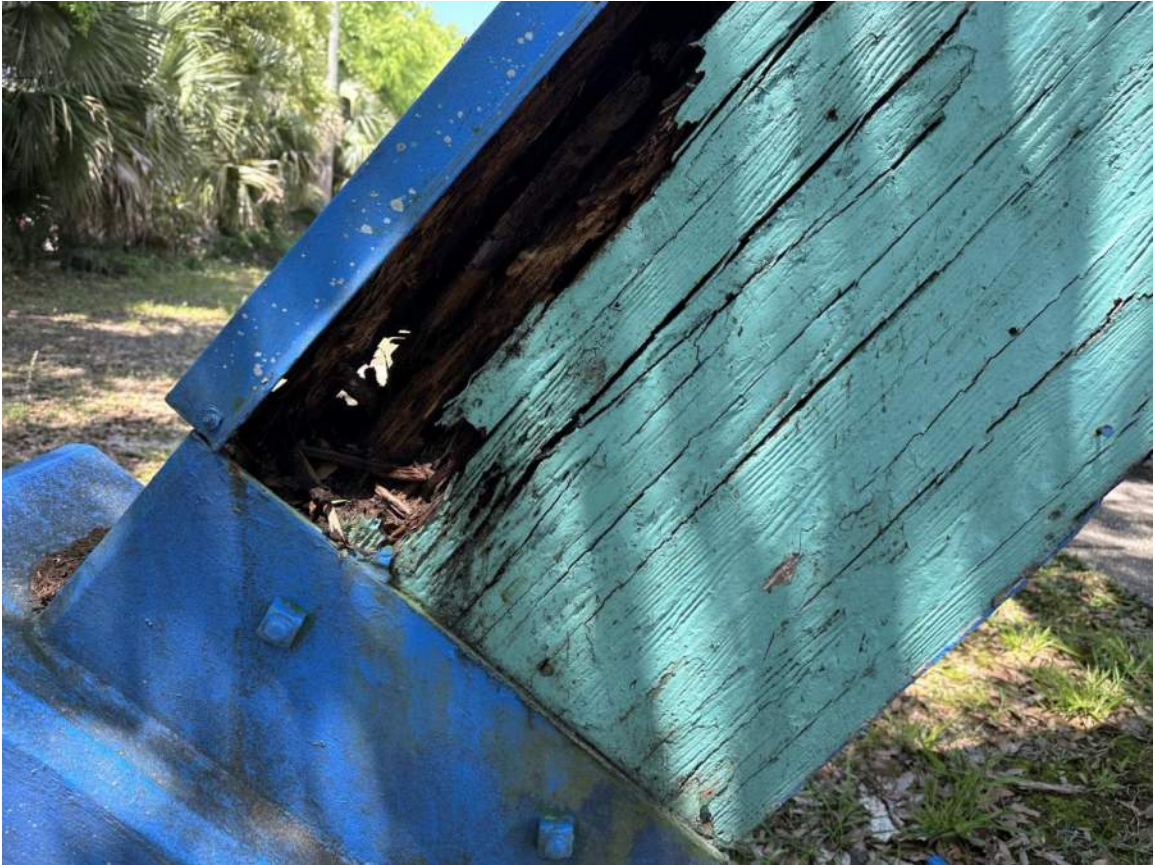
**Arch #1 at South Side of Bldg**  
**(Viewing West End of Arch at Concrete Buttress)**  
**NOTE: Excessive / Severe Decay**

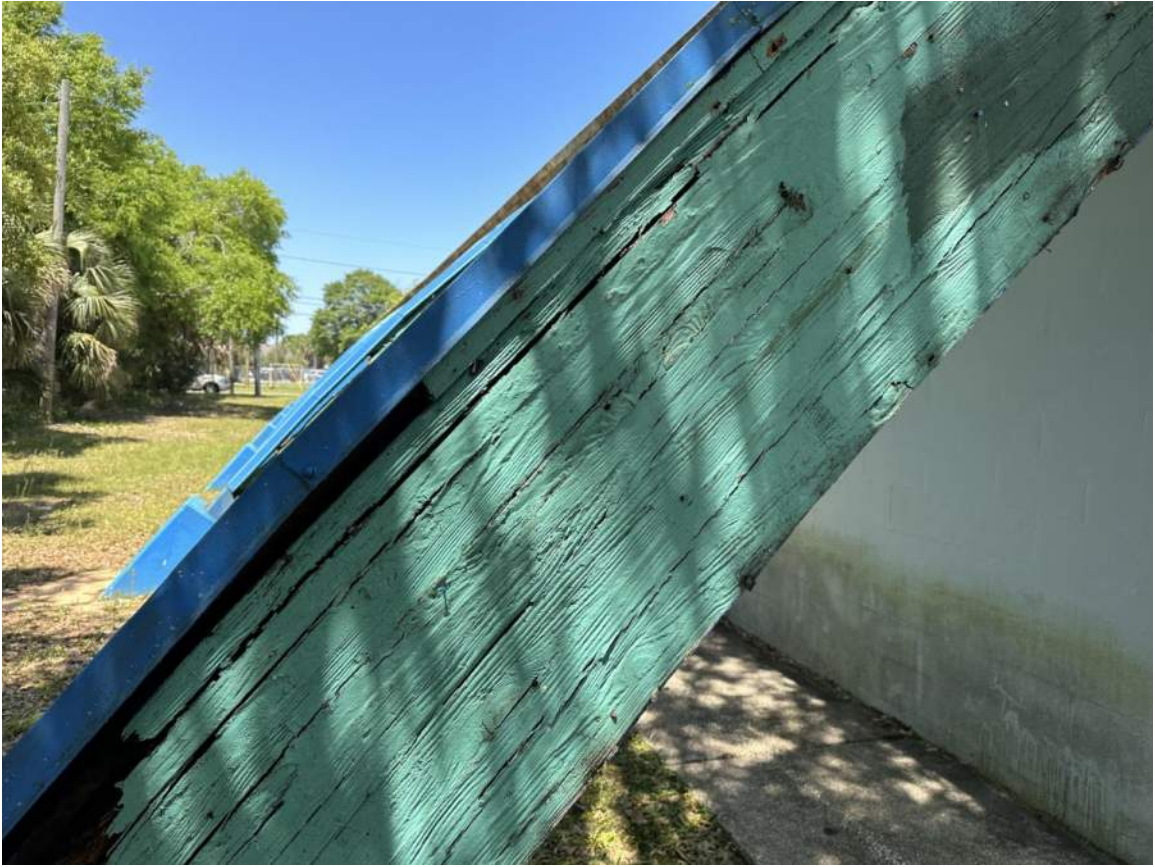
**Arch #1 at South Side of Bldg  
(Viewing West End of Arch at Concrete Buttress)  
NOTE: Excessive / Severe Decay**

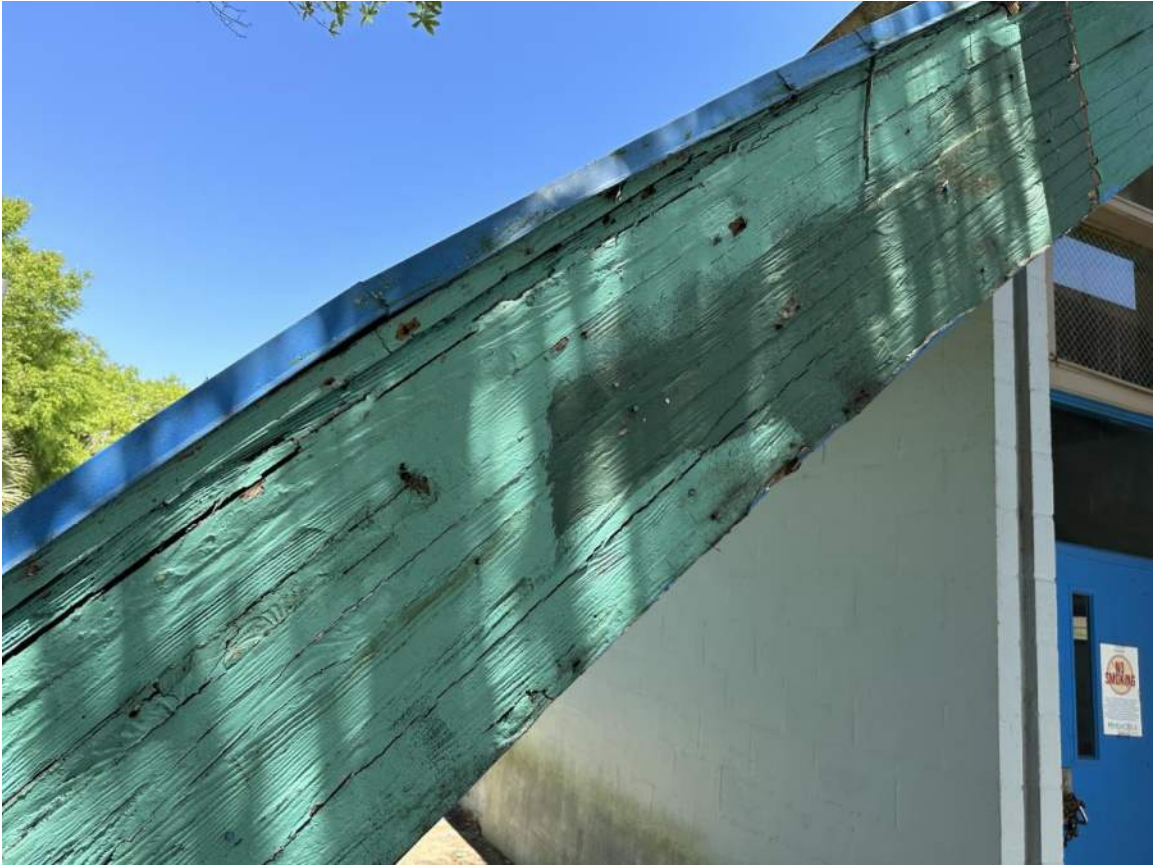
**Arch #1 at South Side of Bldg**  
**(Viewing West End of Arch between Concrete Buttress and west wall)**  
**NOTE: Excessive / Severe Decay & Delamination**

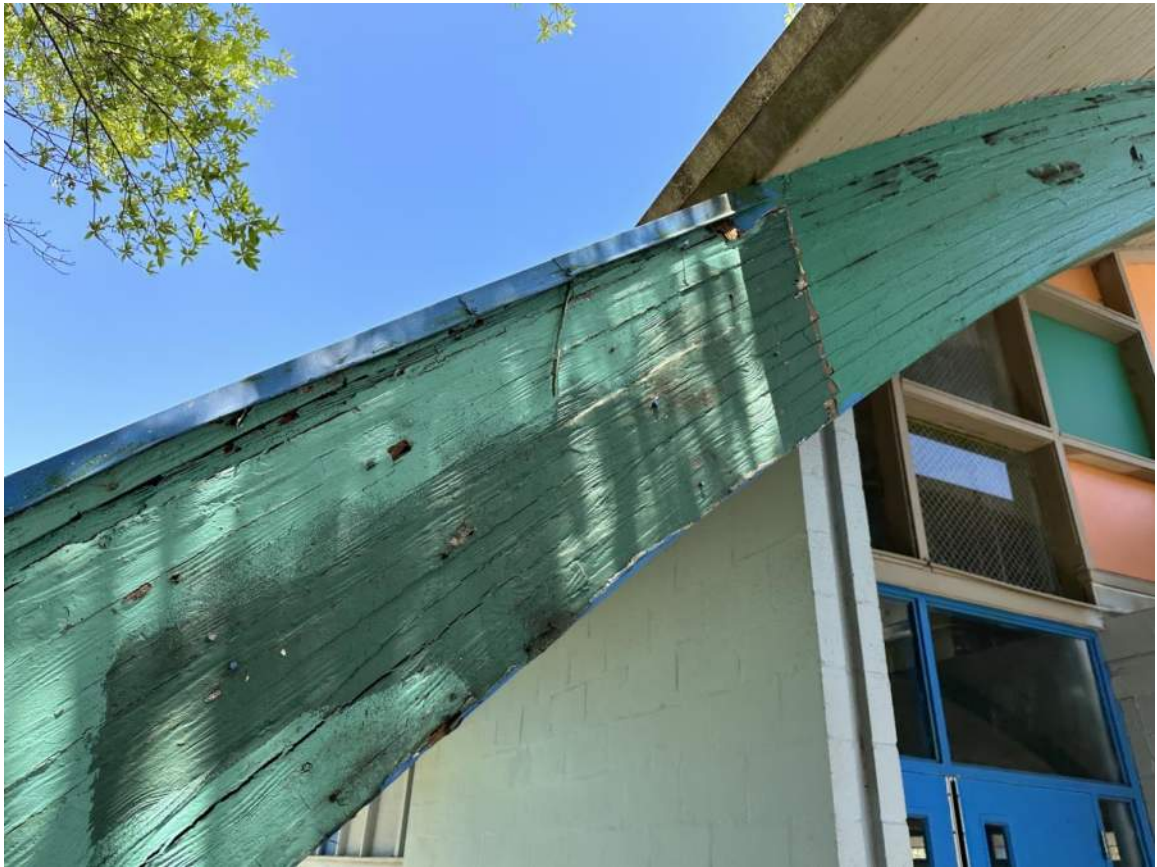
**Arch #1 at South Side of Bldg**  
**(Viewing West End of Arch between Concrete Buttress and west wall)**  
**NOTE: Excessive / Severe Decay & Delamination**

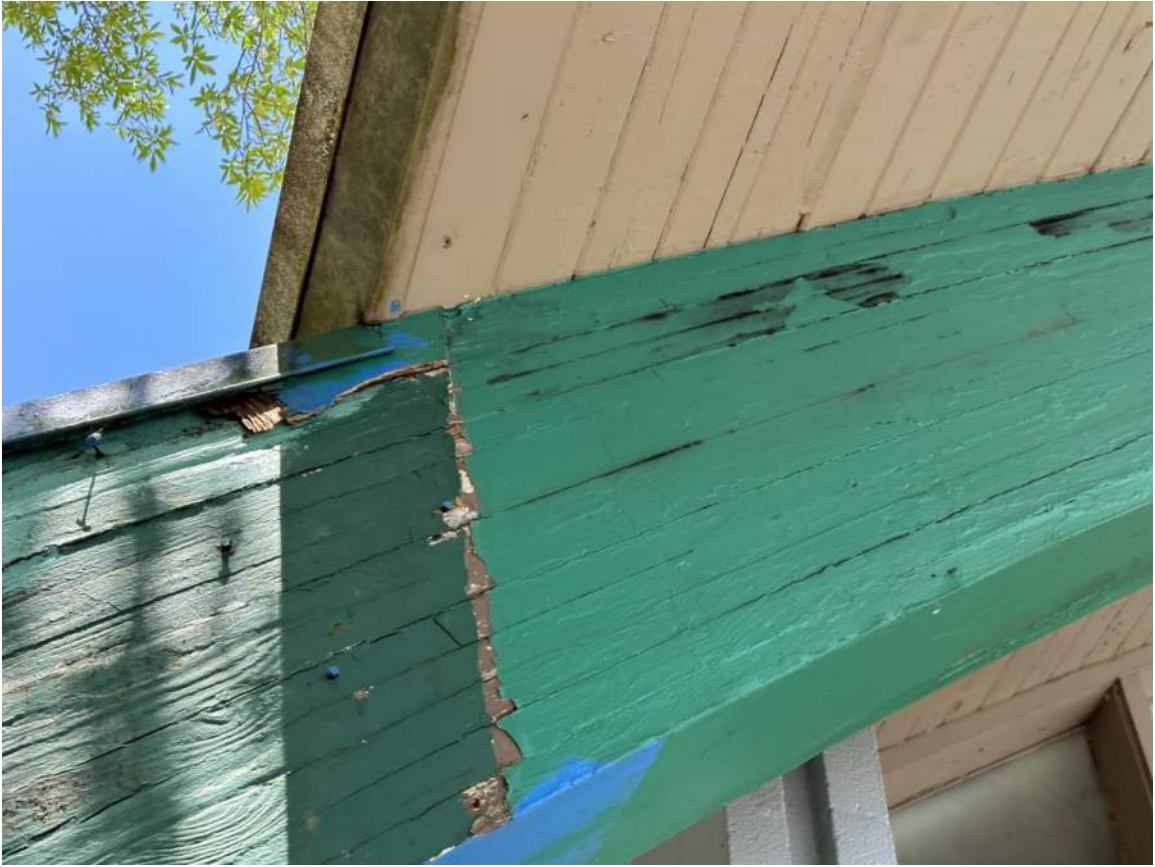
**Arch #1 at South Side of Bldg  
(Viewing West End of Arch at west wall)  
NOTE: Severe Decay & Delamination**

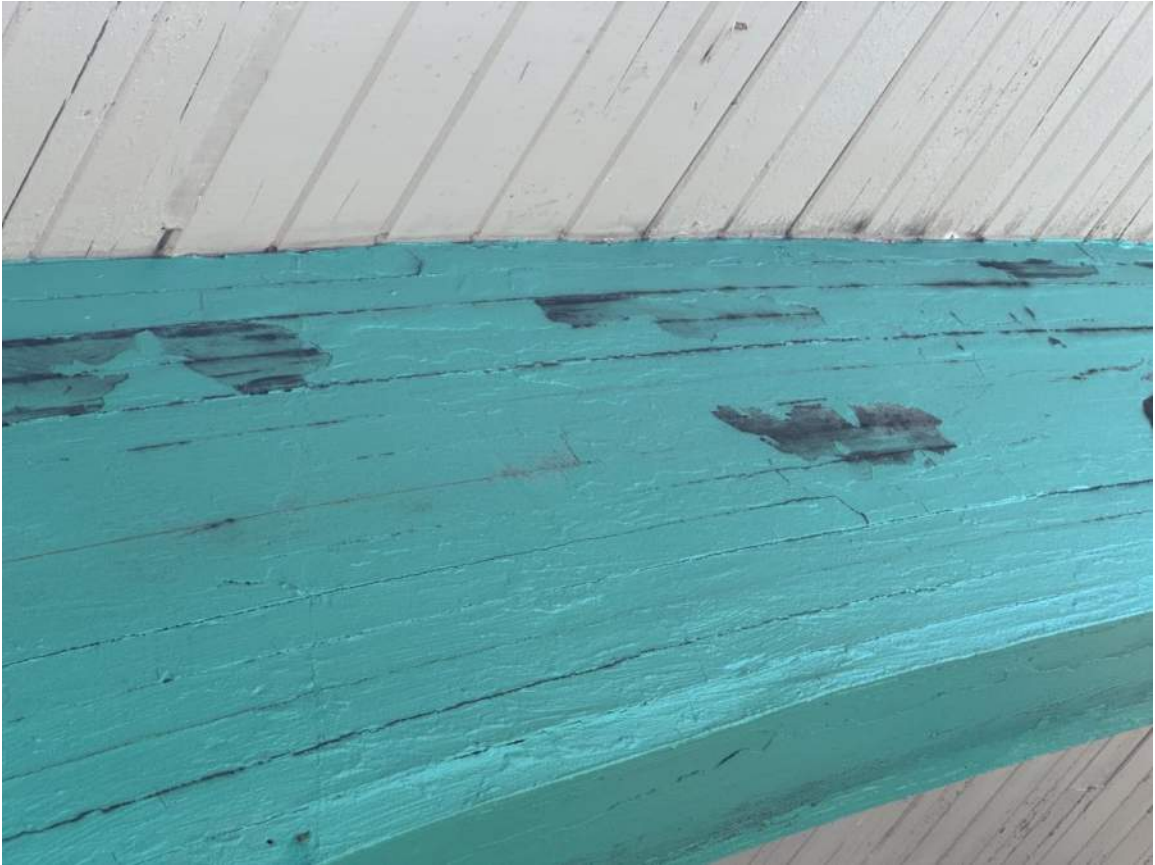
**Arch #1 at South Side of Bldg  
(Viewing West portion of Arch at west wall)  
NOTE: Delamination**

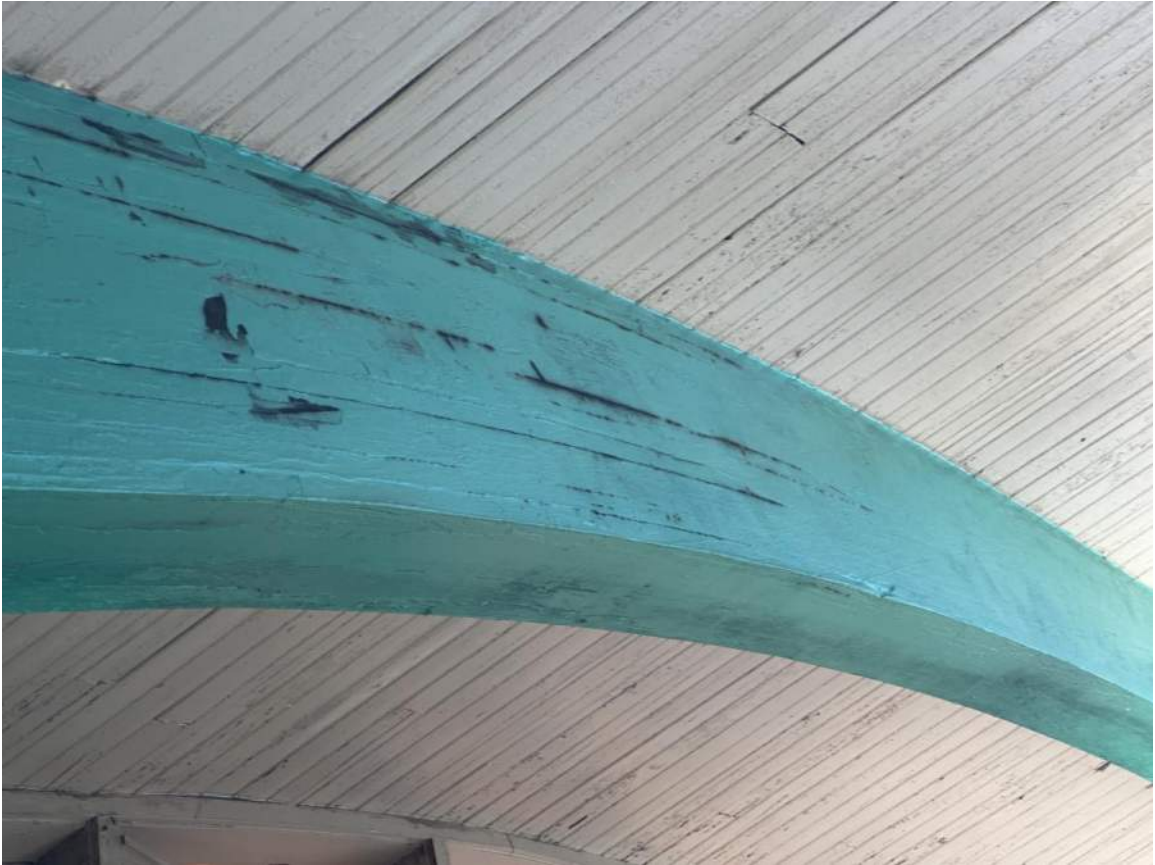
**Arch #1 at South Side of Bldg**  
**(Viewing West portion of Arch between west wall at top of Arch)**  
**NOTE: Delamination**

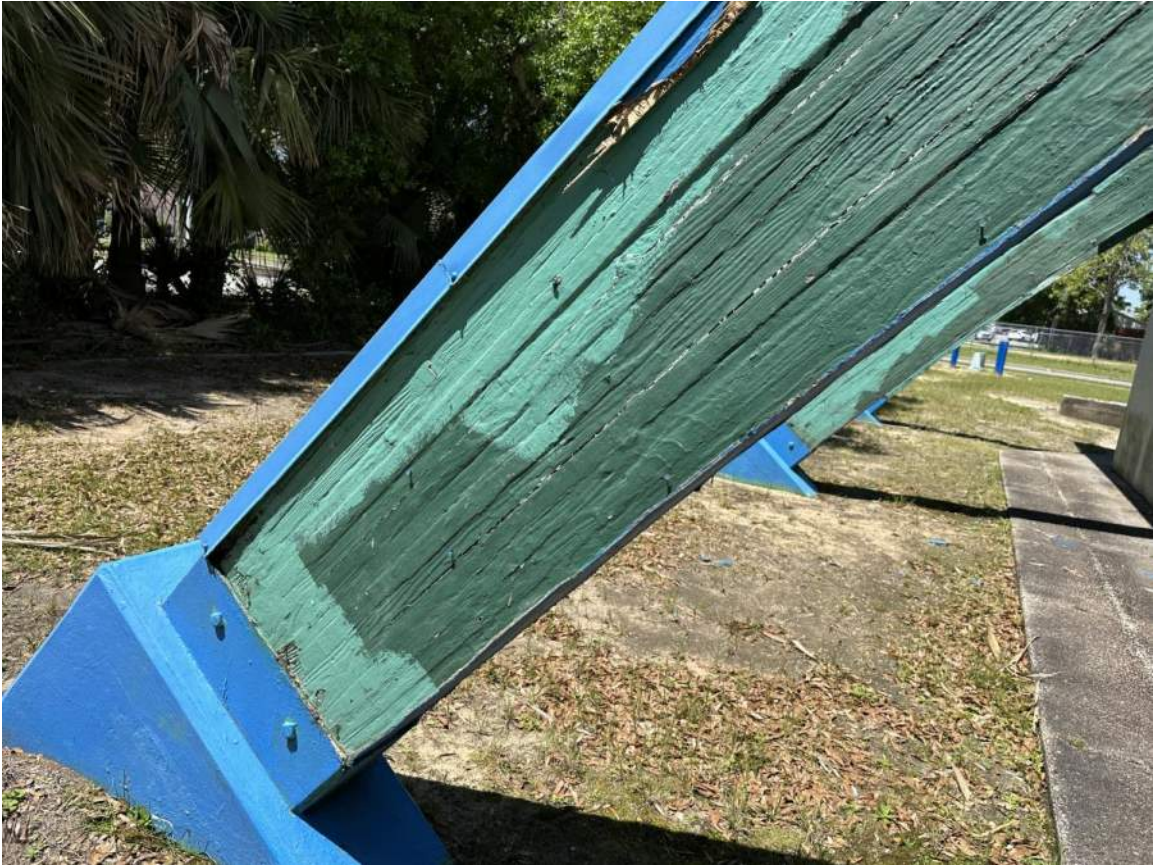
**Arch #2; West End near SW corner of Bldg  
(Viewing West portion of Arch at Concrete Buttress)  
NOTE: Severe delamination & decay**

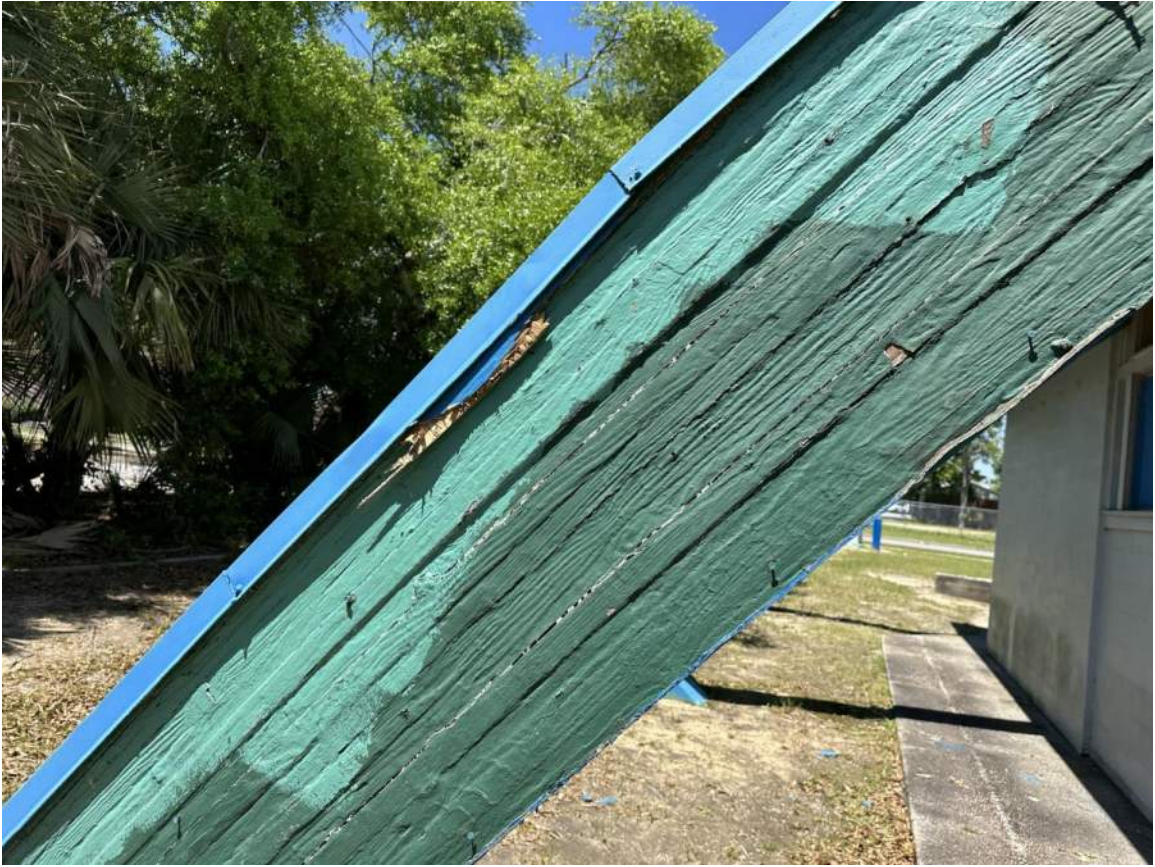
**Arch #2; West End near SW corner of Bldg  
(Viewing West portion of Arch just above Concrete Buttress)  
NOTE: Severe delamination & decay**

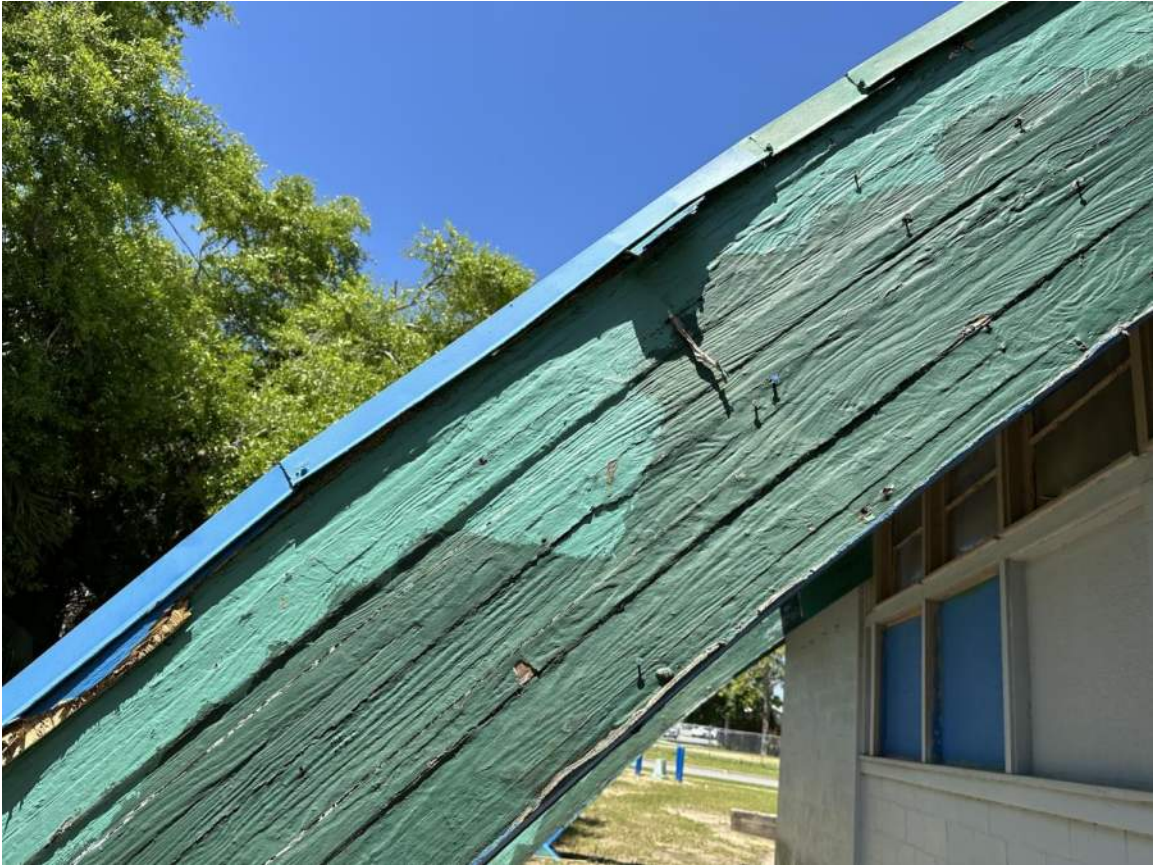
**Arch #2; West End near SW corner of Bldg  
(Viewing West portion of Arch just above Concrete Buttress)  
NOTE: Severe delamination & decay**

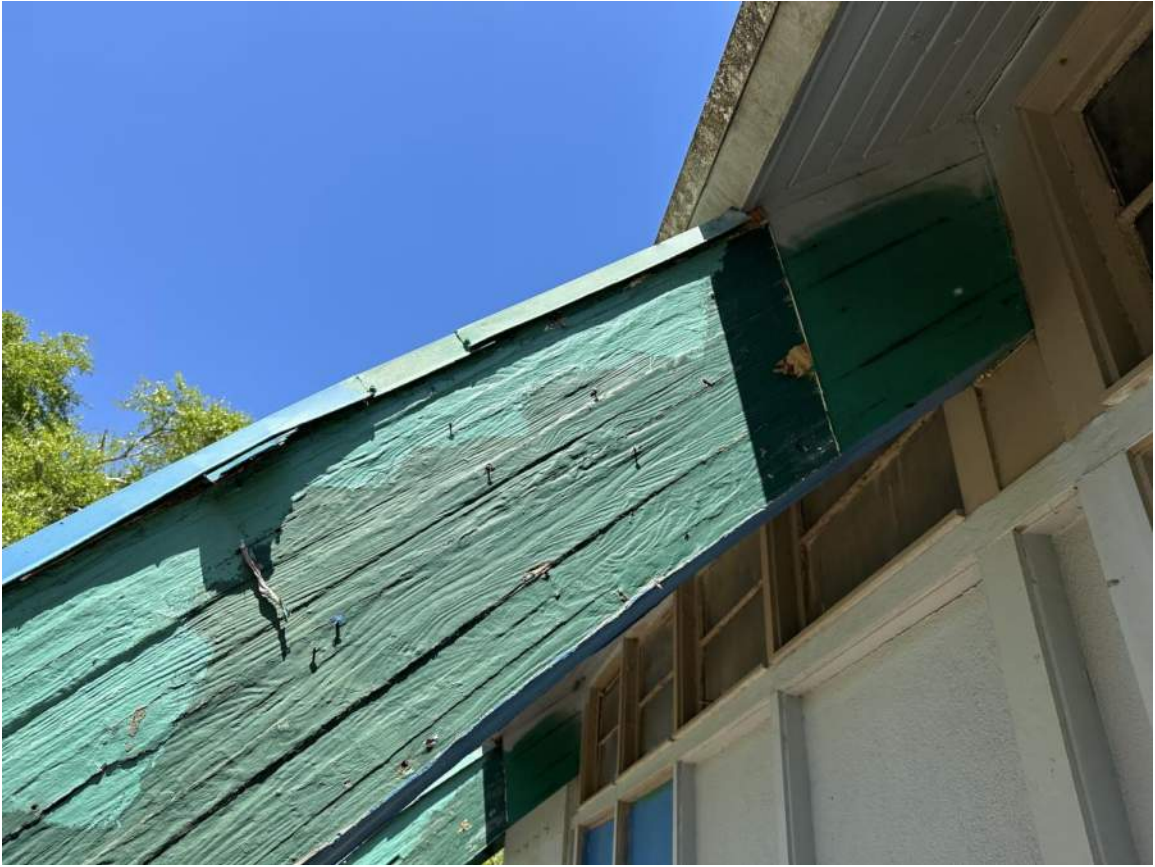
**Arch #2; West End near SW corner of Bldg  
(Viewing West portion of Arch near west wall of building)  
NOTE: Severe delamination & decay**

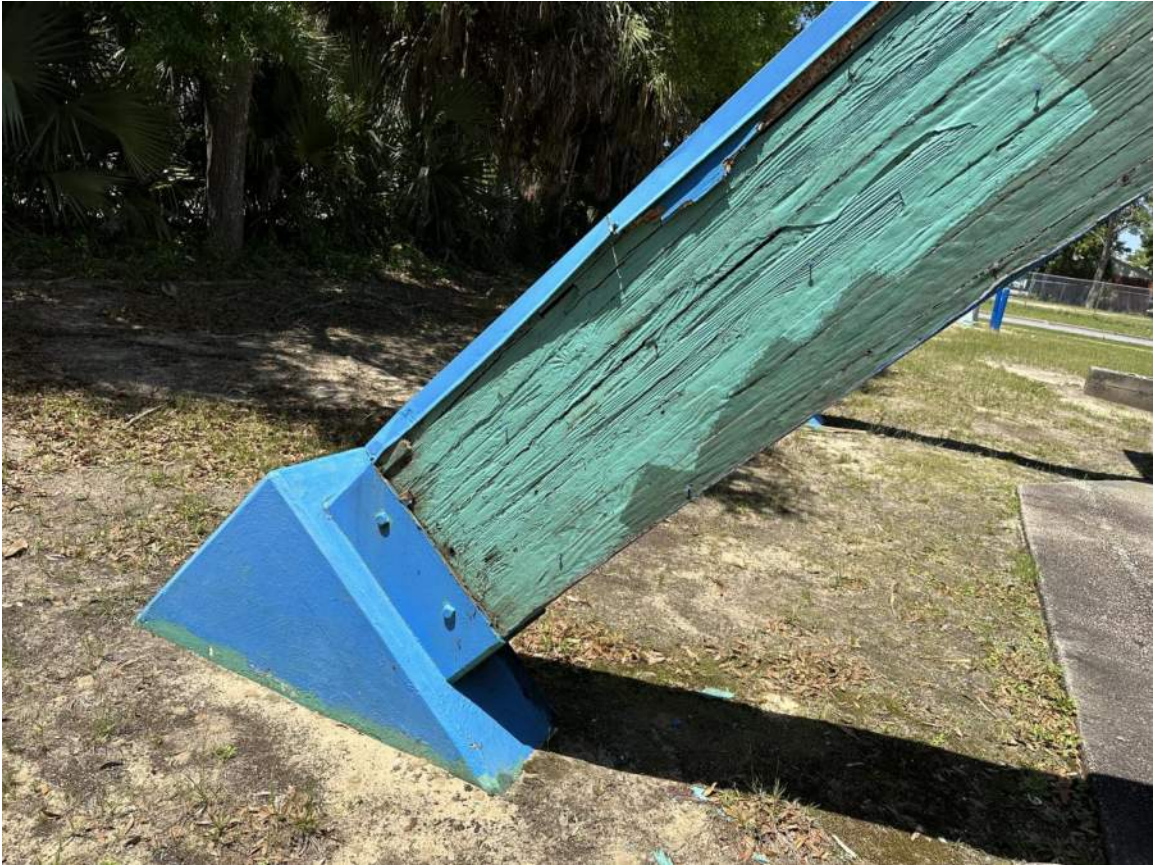
**Arch #6; West End of Arch near NW corner of Bldg  
(Viewing West portion of Arch just above Concrete Buttress)**

**NOTE: Severe delamination & decay**

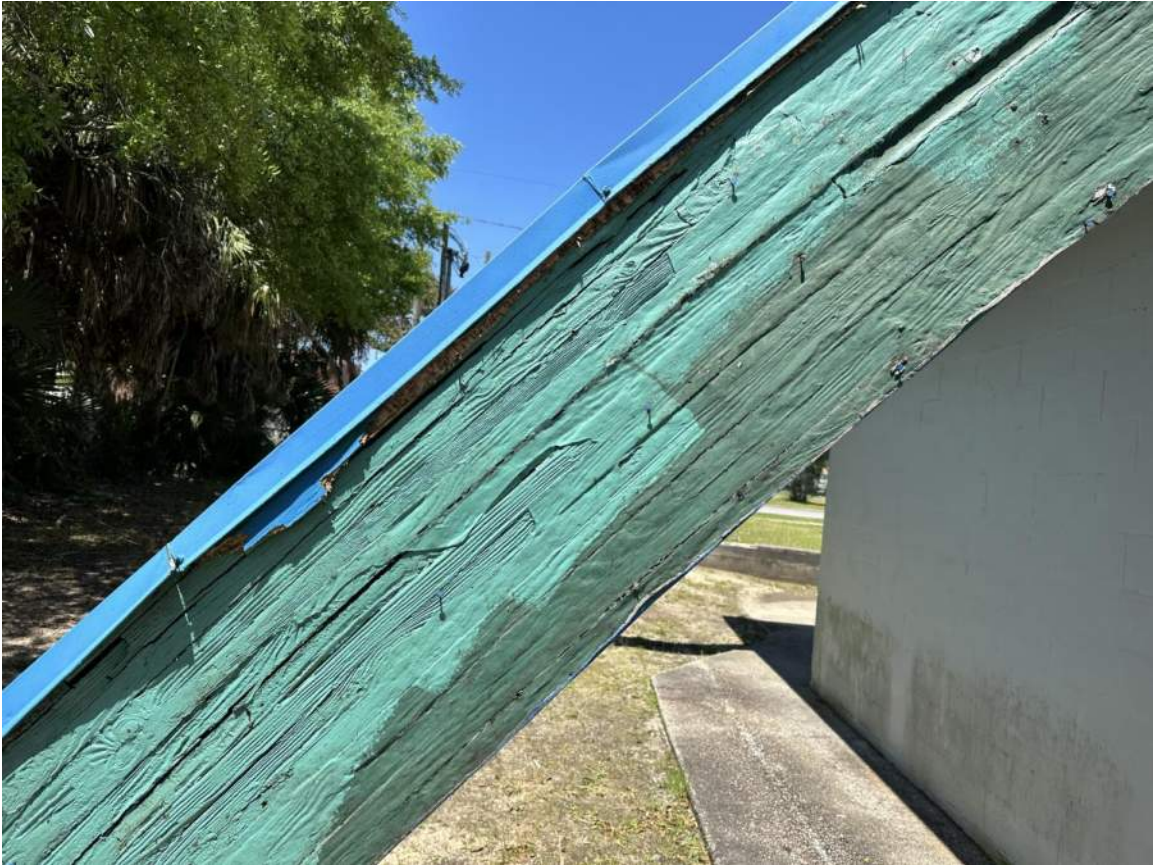
**Arch #6; West End of Arch near NW corner of Bldg  
(Viewing West portion of Arch just above Concrete Buttress)**

**NOTE: Severe delamination & decay**

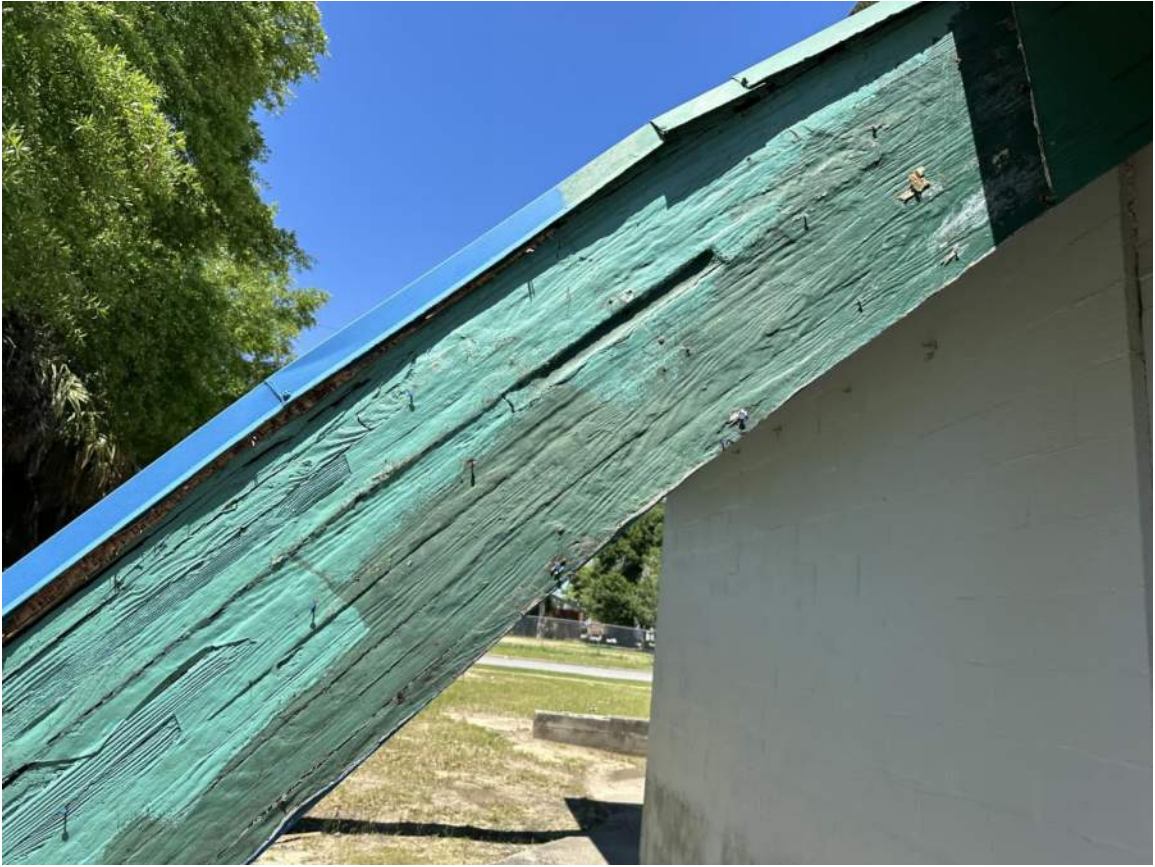
**Arch #6; West End of Arch near NW corner of Bldg  
(Viewing West portion of Arch just above Concrete Buttress and Near West Wall)  
NOTE: Severe delamination & decay**

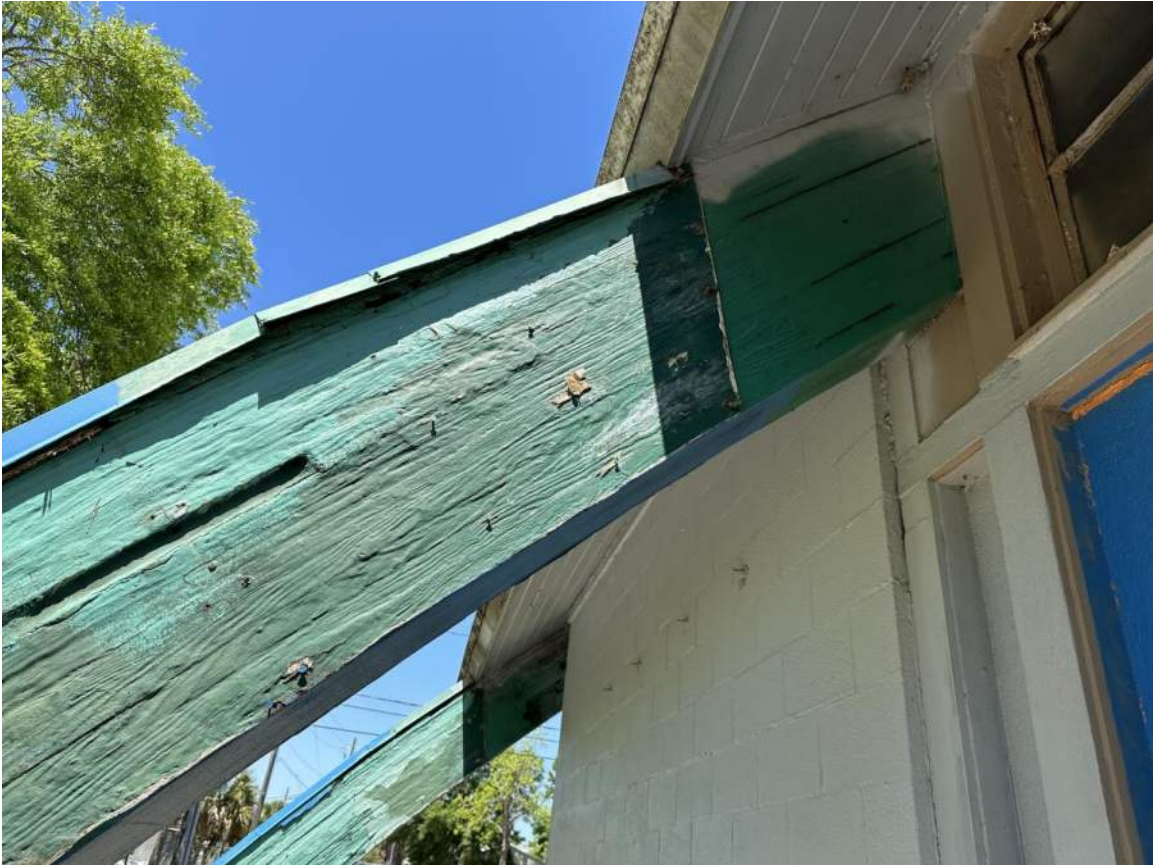
**Arch #6; West End of Arch near NW corner of Bldg  
(Viewing West portion of Arch just above Concrete Buttress and Near West Wall)  
NOTE: Severe delamination & decay**

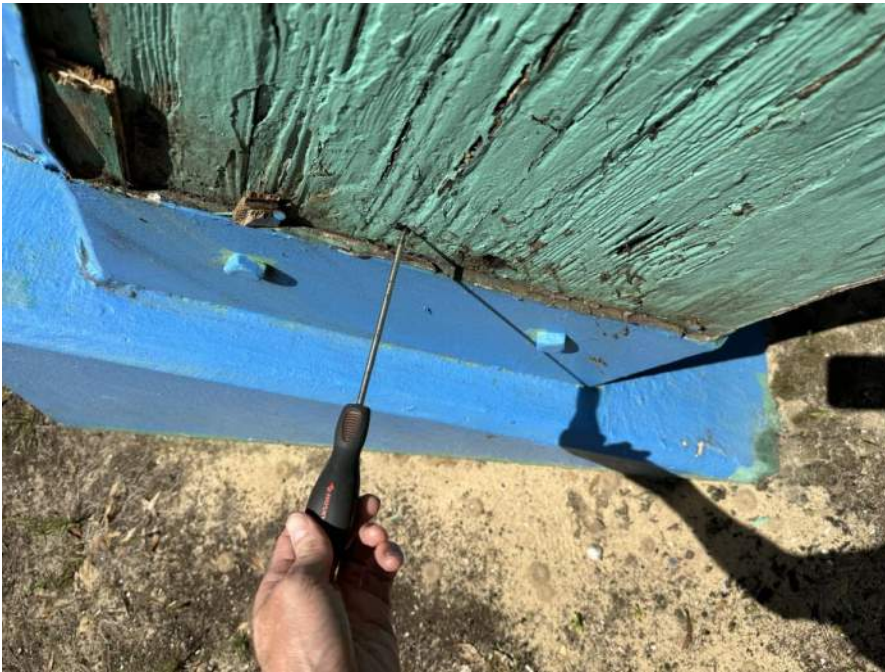
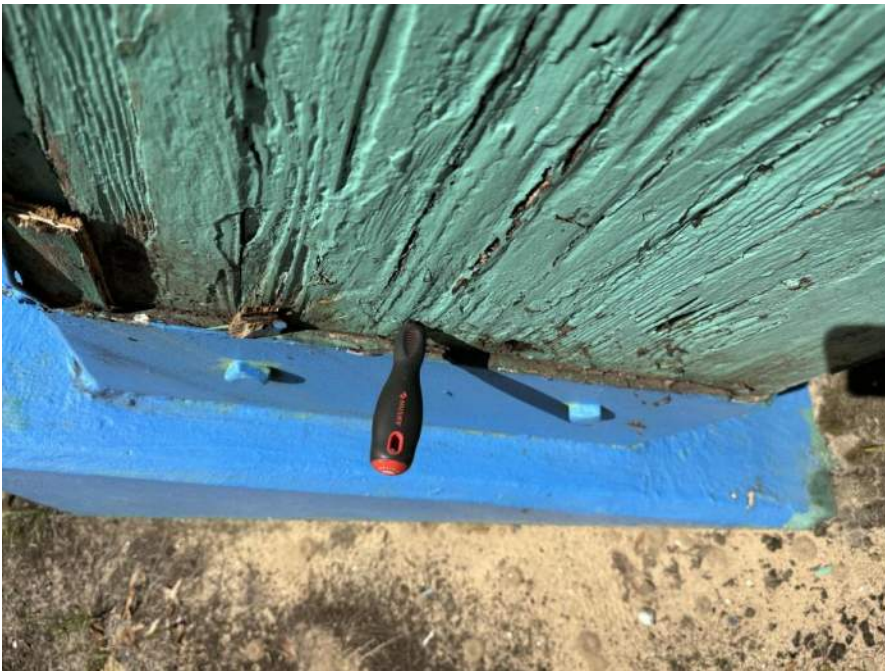
**Arch #6; West End of Arch near NW corner of Bldg  
(Viewing West portion of Arch bearing on Concrete Buttress)**

**NOTE: Severe delamination & decay with screwdriver easily penetrating member**

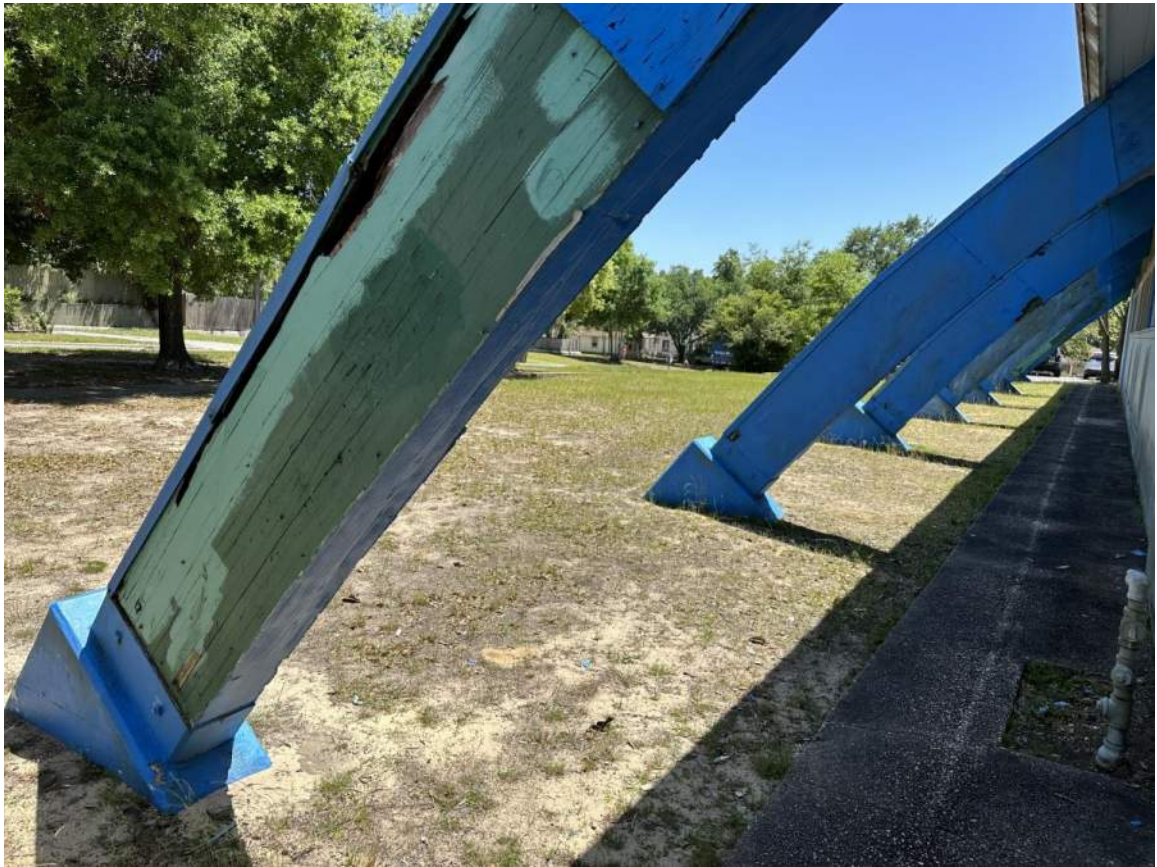
**Arch #7 in Photo Foreground; East End of Arch near NE corner of Bldg**

**NOTE: Severe delamination & decay**

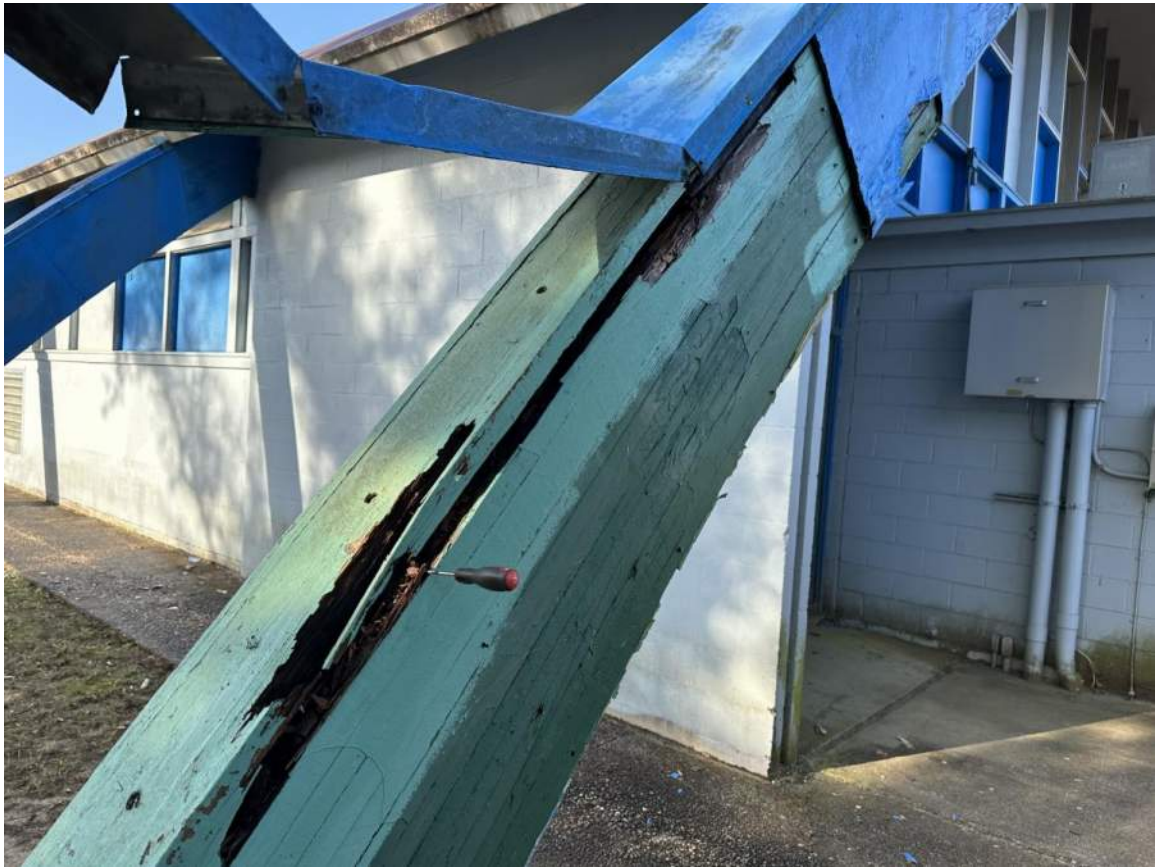
**Arch #7 in Photo Foreground; East End of Arch near NE corner of Bldg**  
**NOTE: Severe delamination & decay**
