## LIMITED STRUCTURAL ASSESSMENT

Glulam Arches at the Malcolm Yonge Center

925 E Jackson St.

April 21, 2023

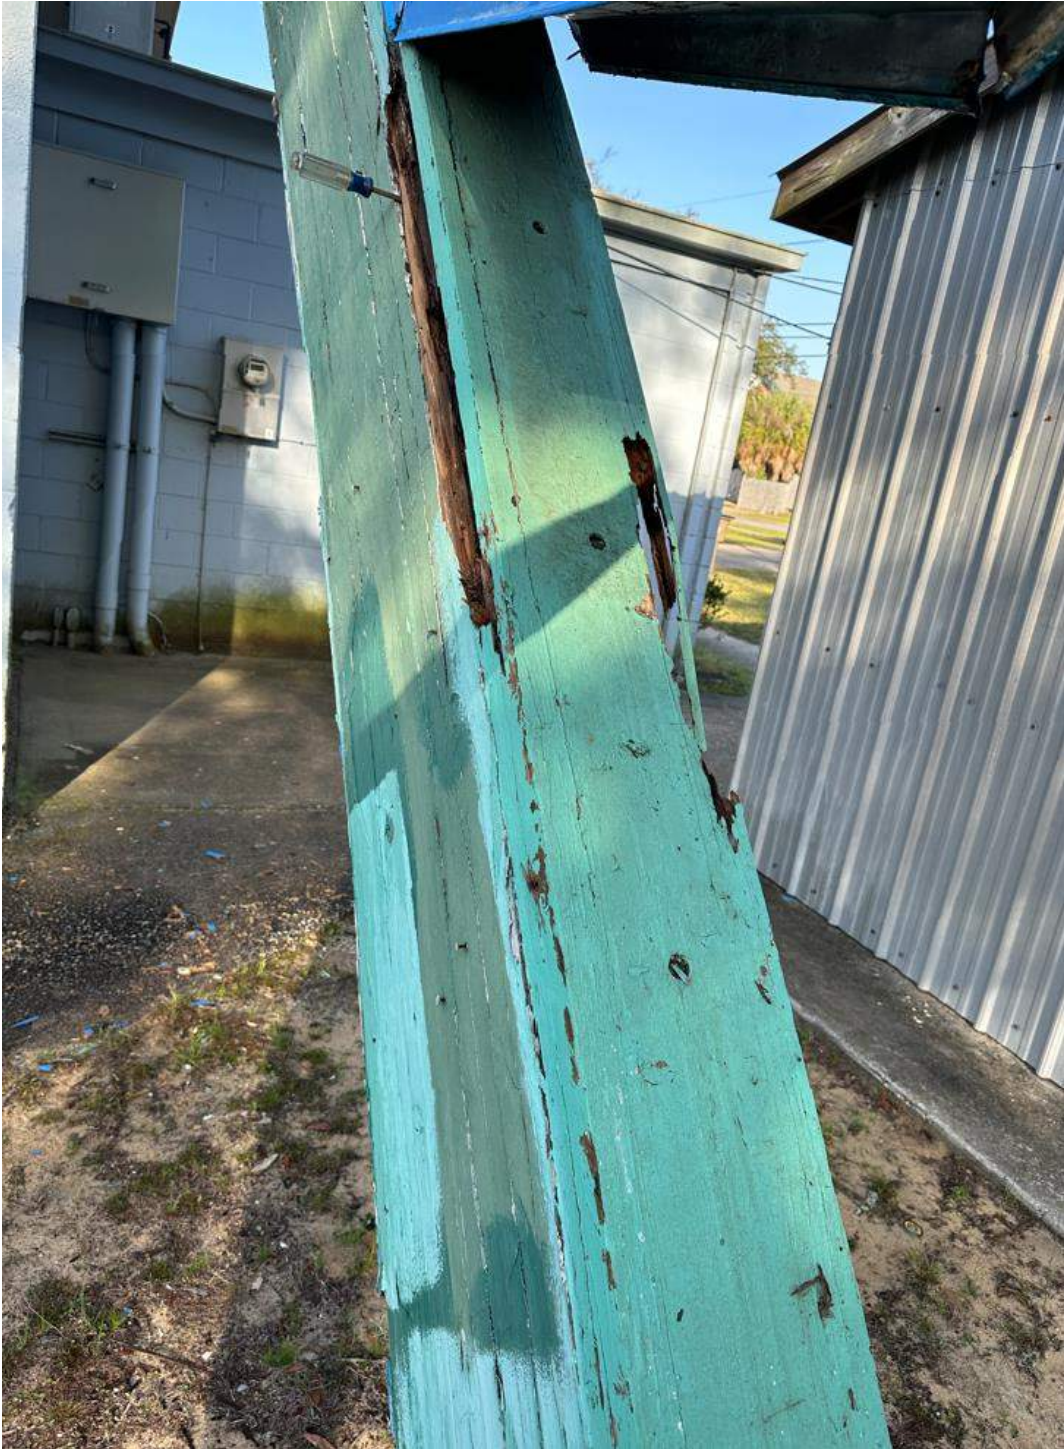
**Arch #7; East End of Arch near NE corner of Bldg**

**NOTE: Severe delamination & decay**

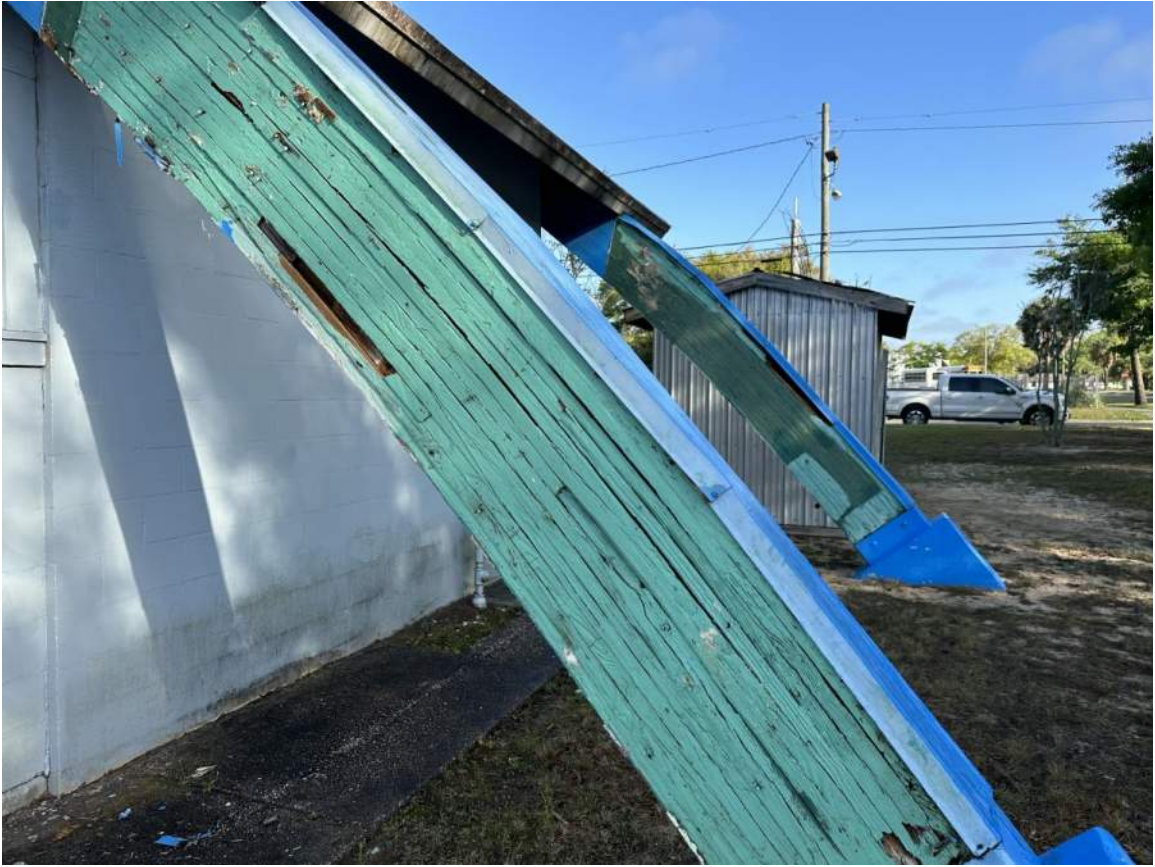
**Arch #6 in Photo Foreground; East End of Arch near NE corner of Bldg**

**NOTE: Severe delamination & decay**

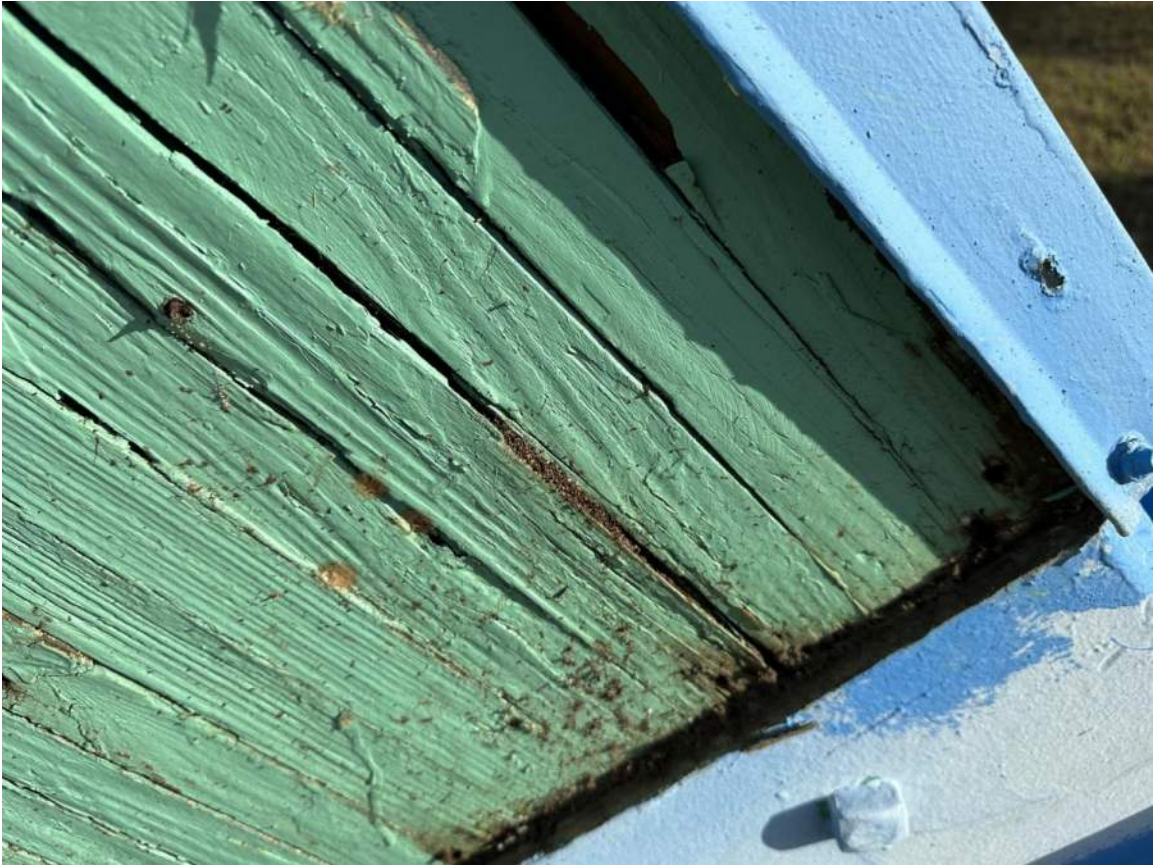
**Arch #4 in Photo Foreground; East End of Arch**

**NOTE: Severe delamination & decay**

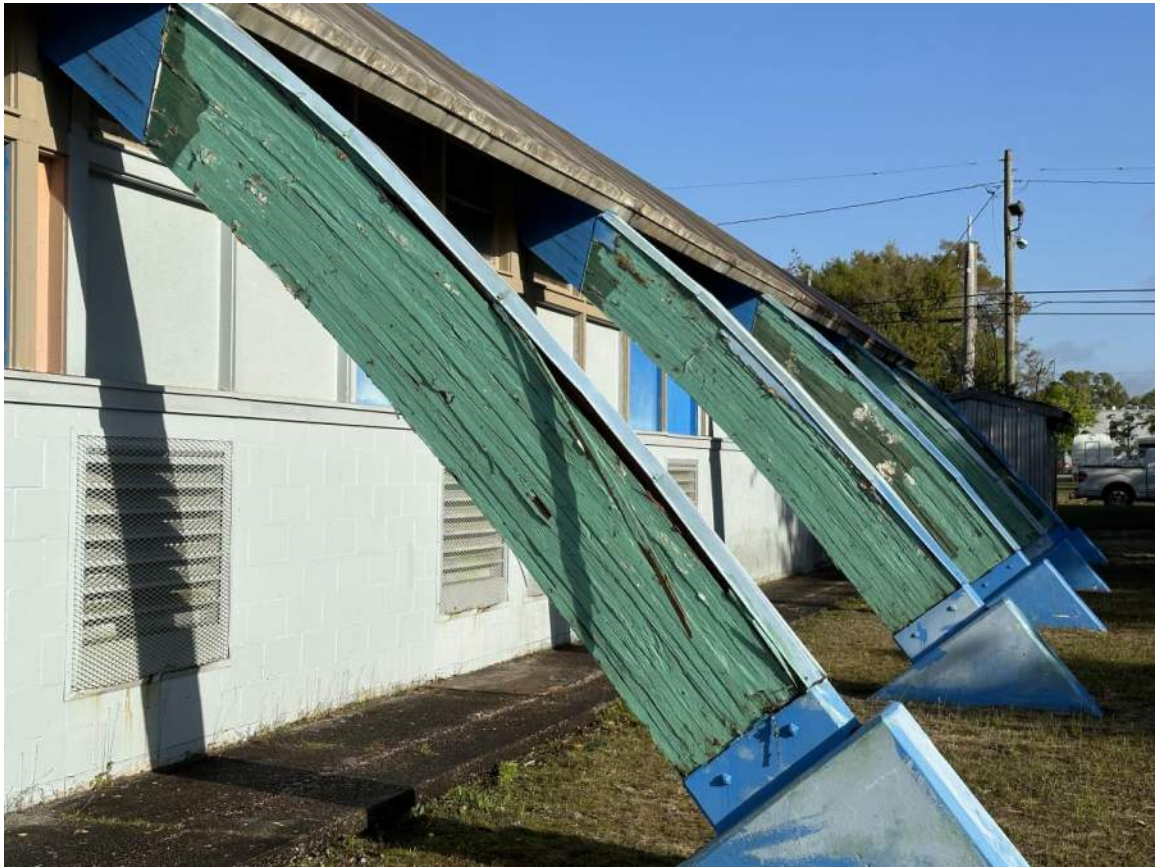
**Arch #3 in Photo Foreground; East End of Arch**

**NOTE: Severe delamination & decay**

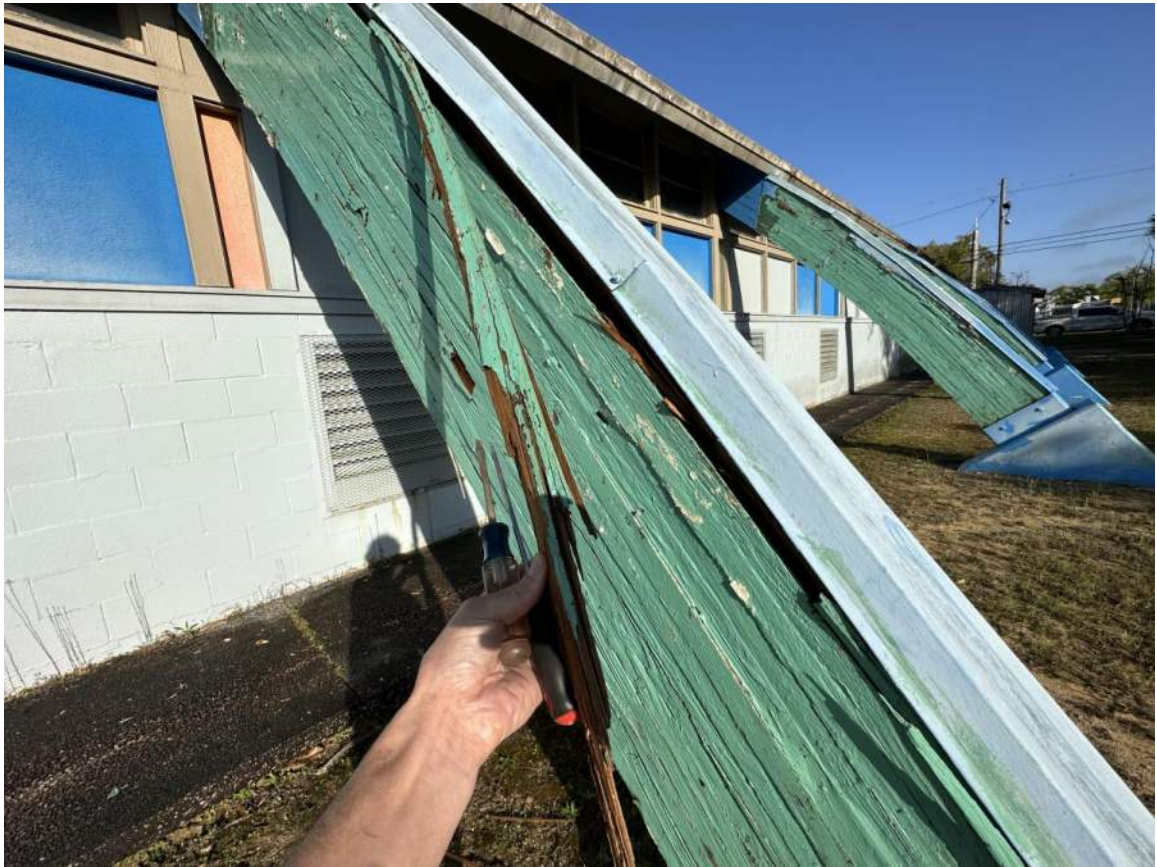
**Arch #3 in Photo Foreground; East End of Arch**

**NOTE: Severe delamination & decay**

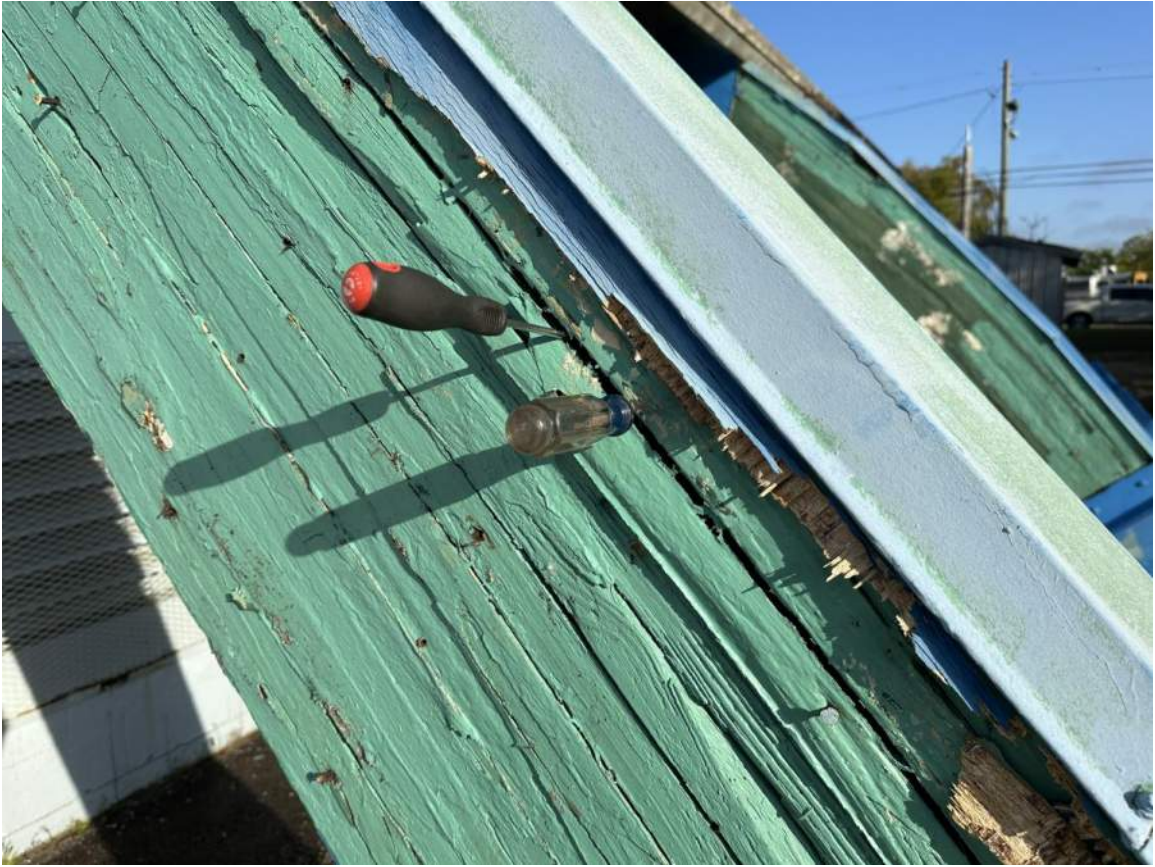
**Arch #4 in Photo Foreground; East End of Arch**  
**NOTE: Severe delamination & decay**

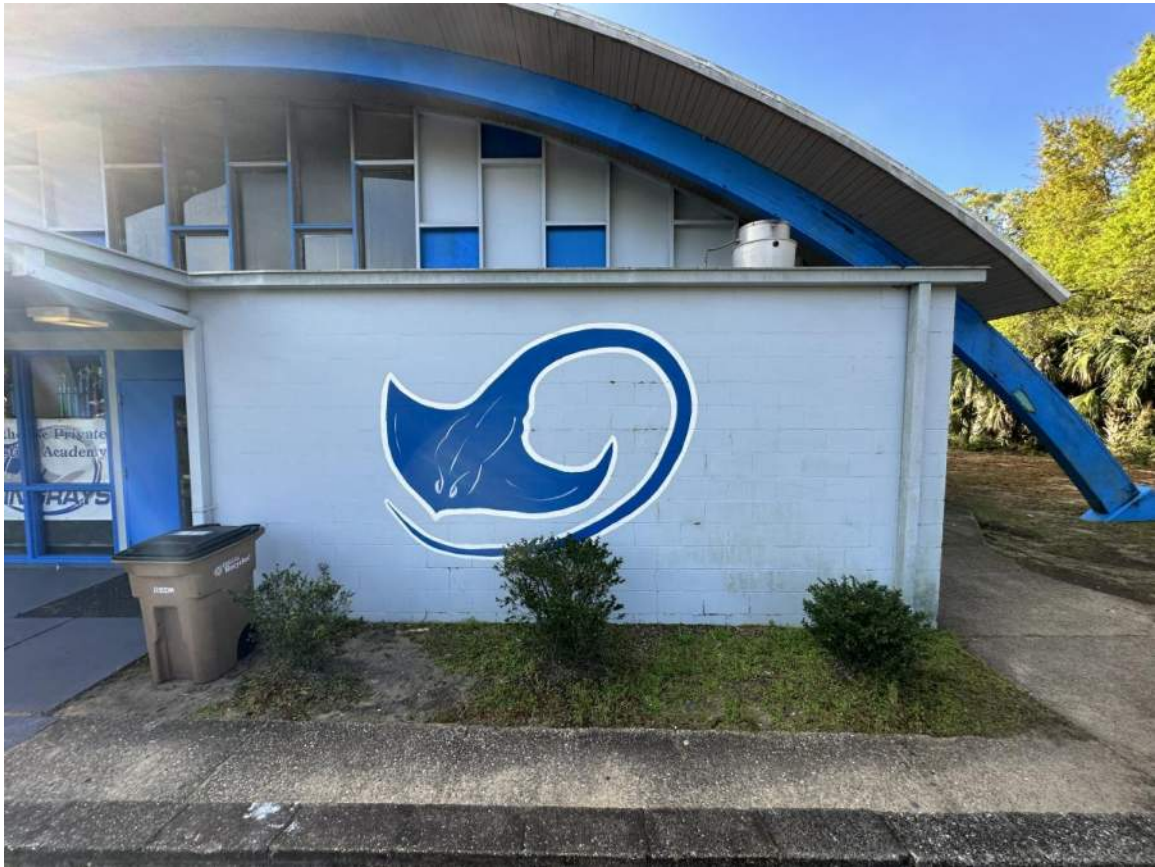
The exterior walls are comprised of concrete block masonry and other glazing systems. We noticed signs of stair stepped cracking along the block walls just west of the north lobby entrance. While the cracking is not severe, it is indicative of differential foundation movement or excessive settlement.

We also noticed stair stepped cracking of the exterior concrete block wall located on the west side of the north lobby entrance.

**Arch #7 & Cracked CMU Wall at North Side of Bldg  
(Looking South)**

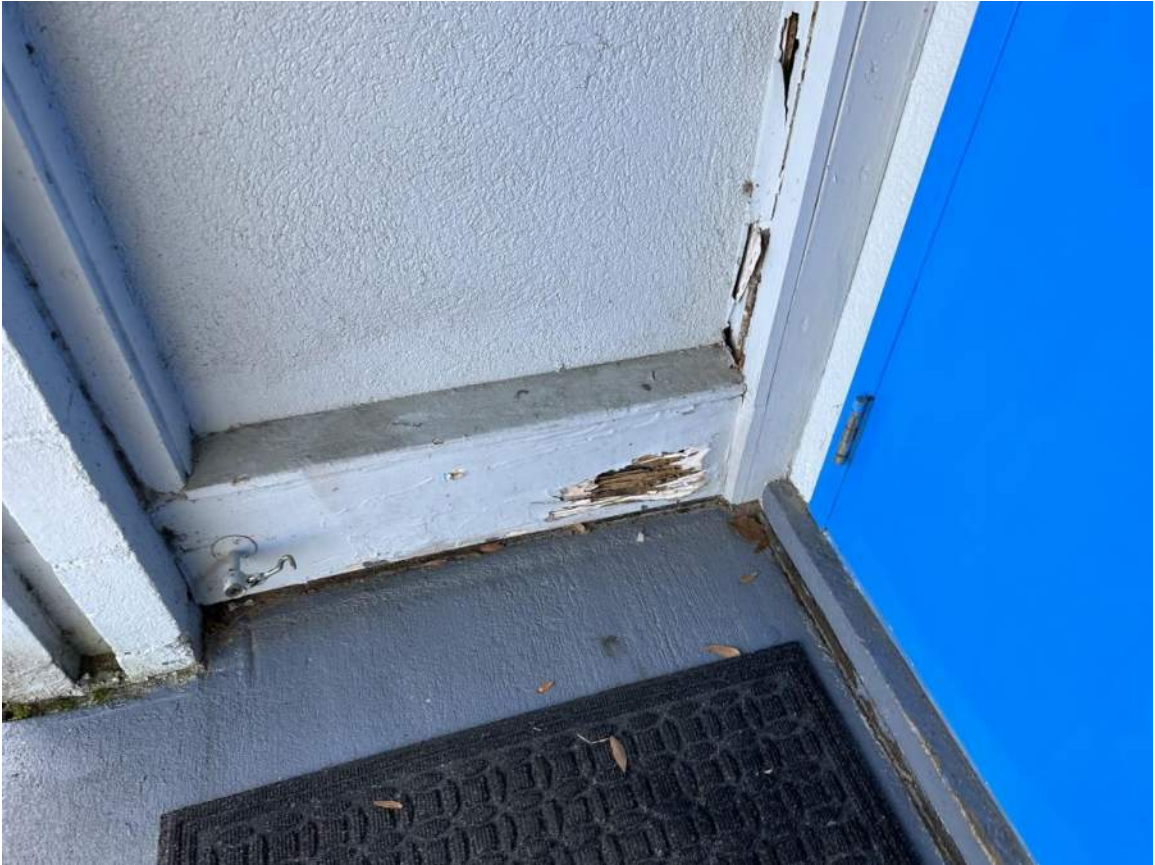
We also noticed termite damage in the wood casework around the exterior lobby doors on the north side of the building. A complete inspection of the entire facility for wood destroying organisms should be conducted by appropriate personnel.

There is termite damage to some of the casework around the north lobby entry doors.

**Termite Damage at North Lobby Entrance**

An inspection of the entire facility for wood destroying organisms should be conducted by appropriate personnel and a report provided.

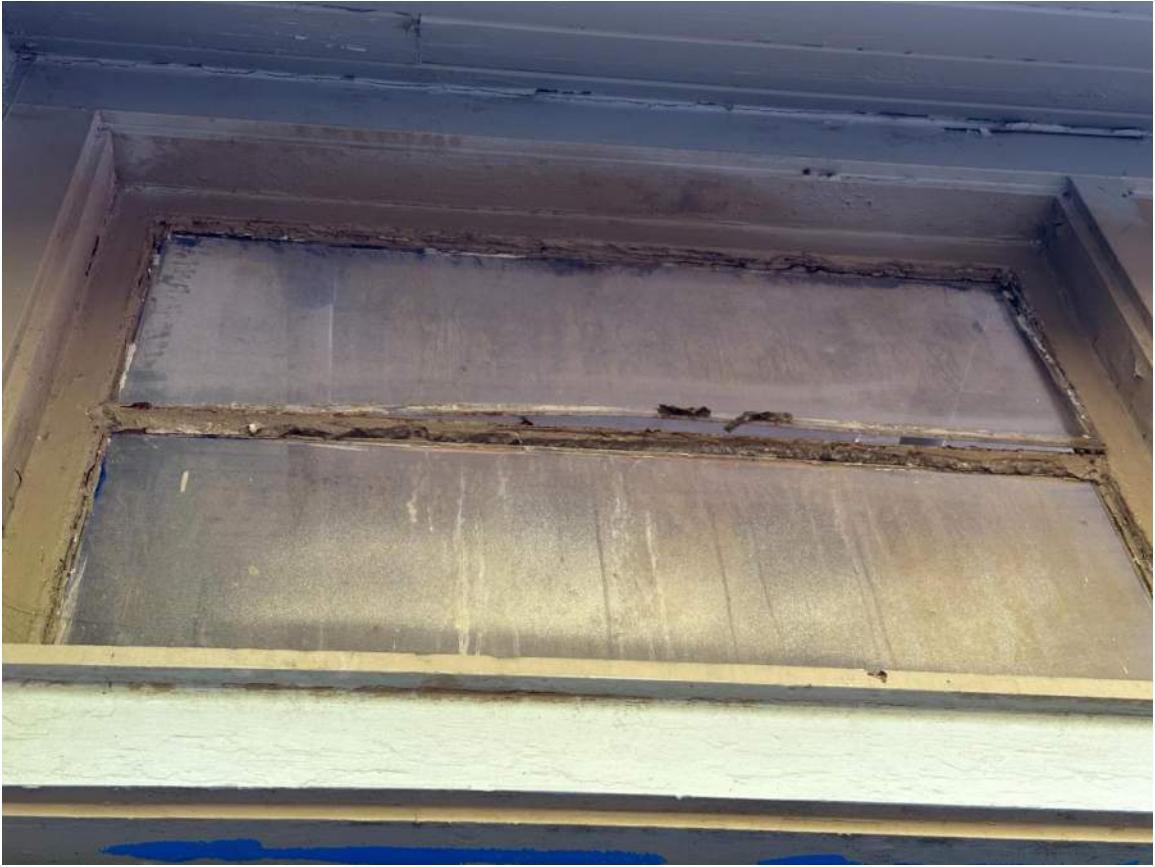
**Typical Window Condition**  
**(Note obvious damage and poor condition of framing and glazing)**
